# Bushfire Burnover Assessment of the By Joost Greenhouse : February 2012

Report number : EP121799

Date: July 2012

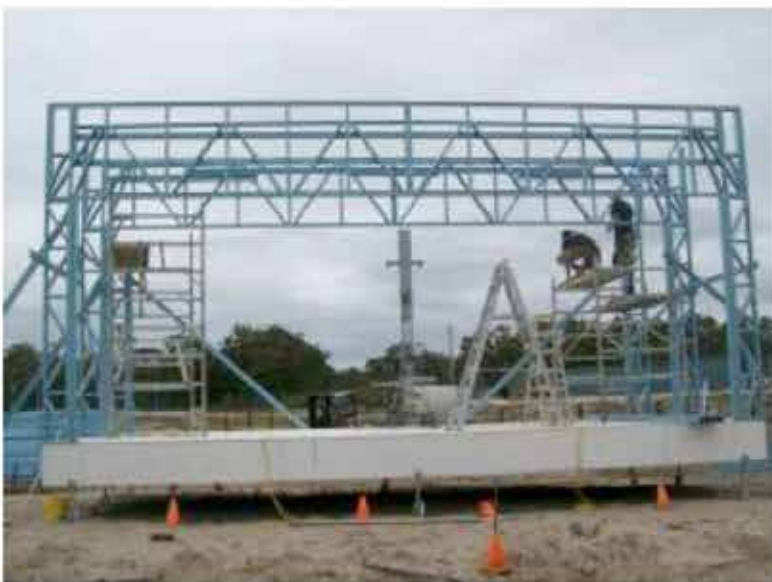
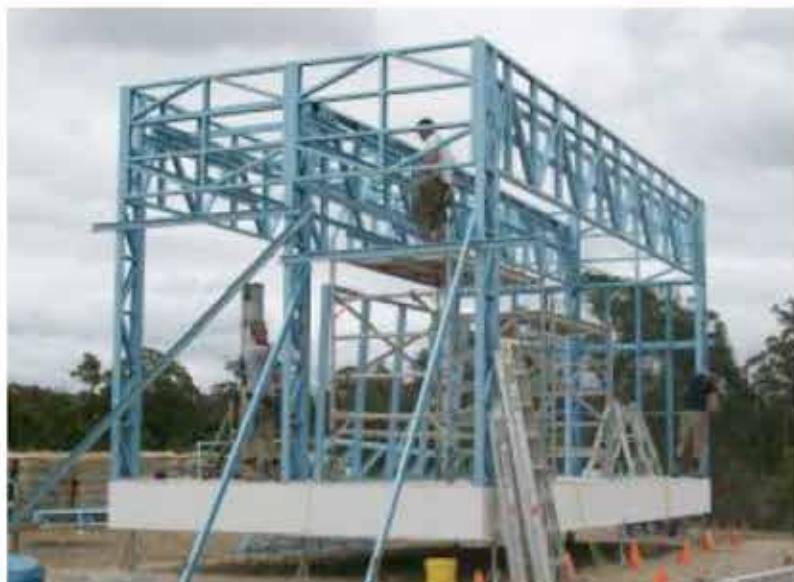
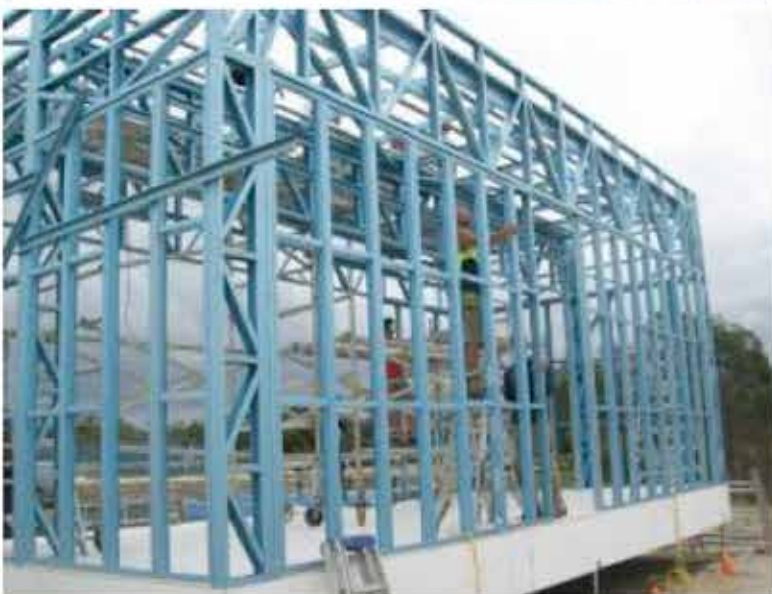
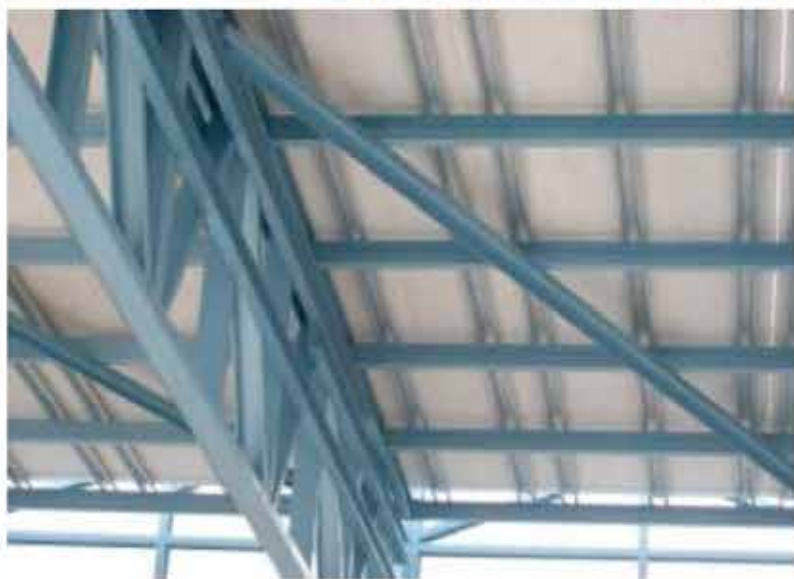
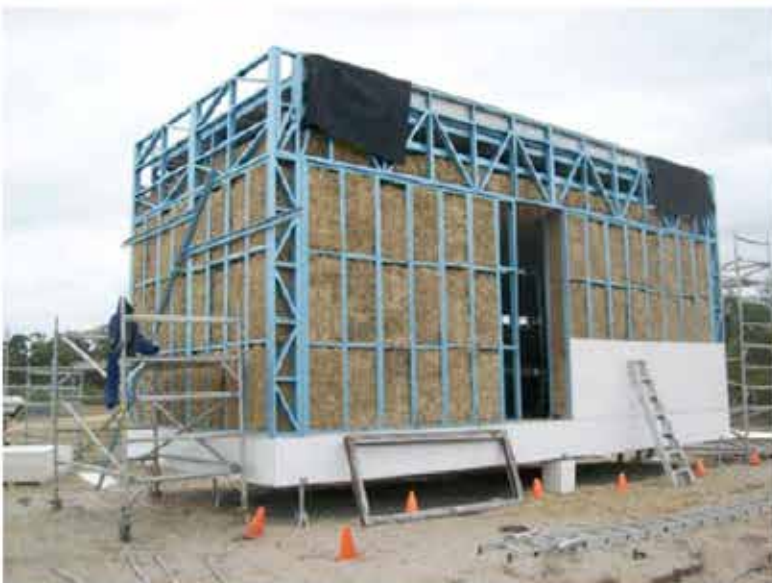
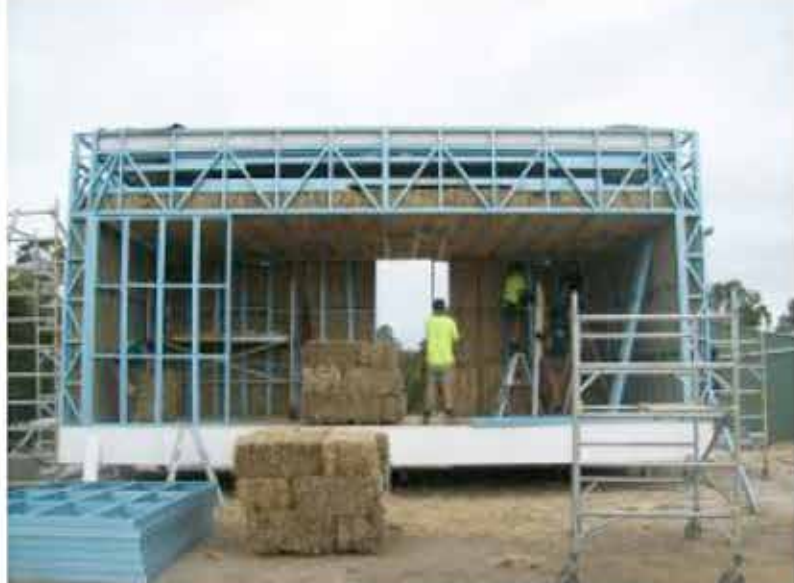
Figure 10 House construction part 2

( clockwise from top left: Top truss of portal frame; Roof framing; Roof lining; Installation of straw bale wall insulation; Roof membrane and external wall cladding)

The house consisted of a portal frame/truss construction which provided clear spans between external walls (see Figure 10). All the framing except for the roof battens were constructed from light gauge steel 90mm x 42mm by 1mm thick cold rolled channel sections (see Figure 12). The frame was constructed using screwed joints. In the walls and portal frame the joints were recessed so the screw head is flush with the surface of the frame (see Figure 12). The floor, wall and roof cavities were sized to accommodate 950x400x450mm straw bales. All exposed faces of the building except the roof were lined with a double layer of 10mm FireCrunch board fasters to the frame by self-drilling, countersunk screws(see Figure 14).. The first layer was screwed at 300mm centres along each stud. The second layer was also screwed at 300mm centres offset by 150mm. The double layer provided a lap over any joints and redundancy if the outer layer becomes deformed or cracks. Due to shortage of material only part of the back wall had a double layer, strips of board were used to cover all joins in the back wall. The roof was protected by ~150mm of soil. All external gaps and joints were sealed with Tremco “TremStop Pu” polyurethane sealant (<http://www.tremco.com.au/docs/techsheets/TREMstop%20PU.pdf>) (see Figure 13)

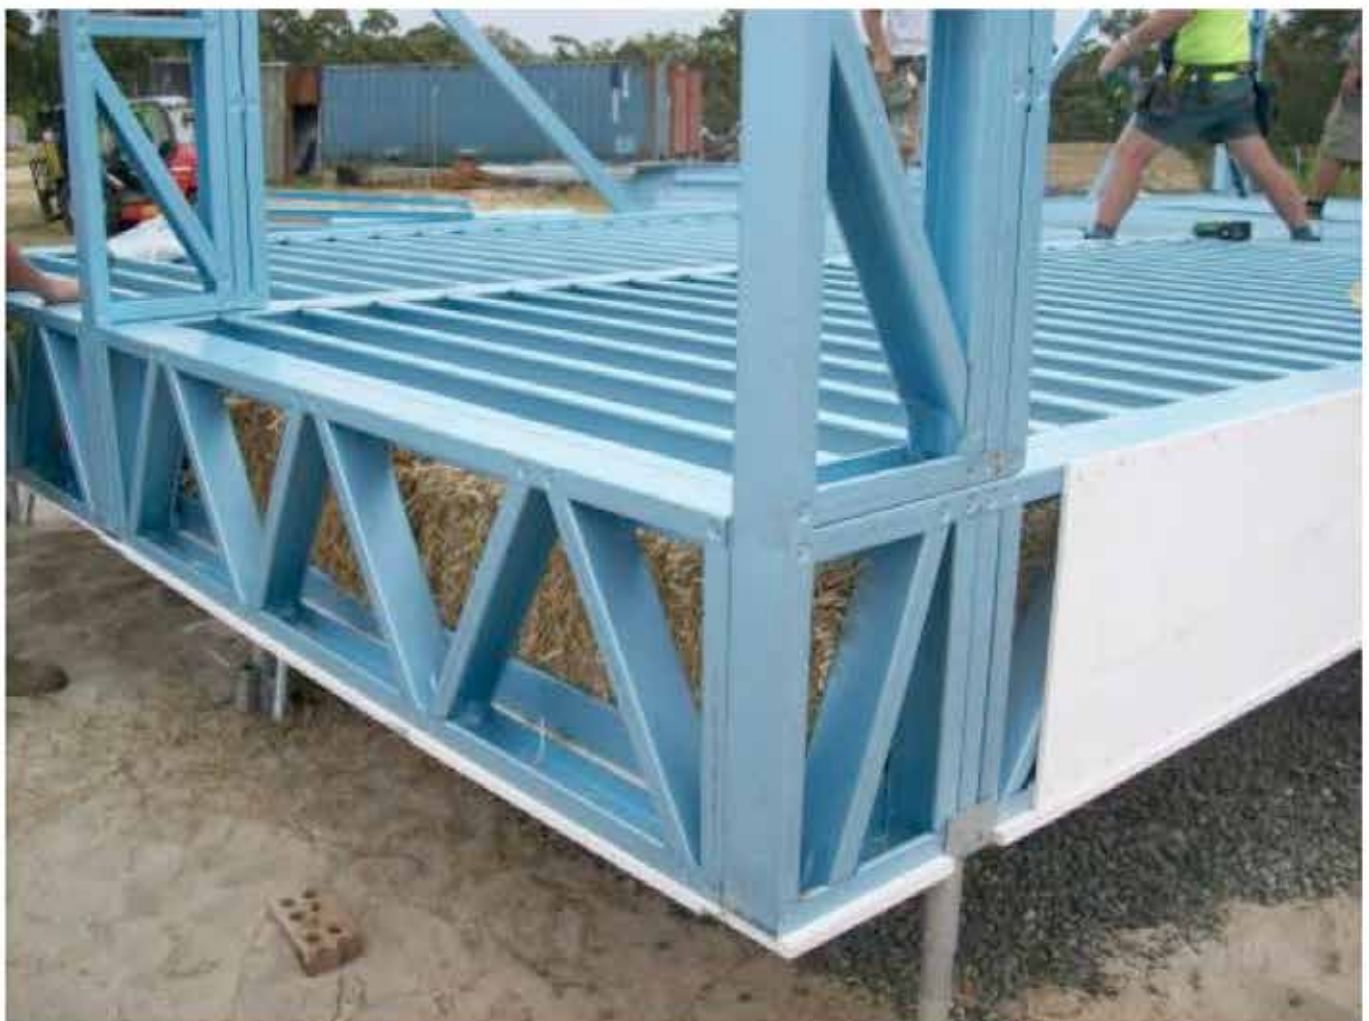
Figure 15 Floor system

The floor system (see Figure 15) was supported by three 500mm deep truss bearers each of which forms the base of a portal frame. The floor was suspended 0.5m off the ground on 9 steel stumps to provide a worst case bushfire scenario allowing entry of flame to the underfloor, although the preferred construction system would be slab on ground. For practicality Mega Anchor (<http://www.mega-anchor.com.au>) foundation/stumps were used to support the floor system. This had the advantage that they were easy to install into the test pad and could be removed at the end of the testing. Both the flooring and the underside lining are supported by joists that span between the bearers and are screwed to the side of the top and bottom chords of the bearers. The underside lining consists of a double layer of 10mm thick FireCrunch board the flooring is a single layer of 20mm FireCrunch board. The floor cavity is filled with straw bales with a ~100mm air gap between the top of the straw and the flooring. The outside face of the bearers are also lined with a double layer of 10mm thick FireCrunch board.

**Note.** A localized buckling failure occurred in the bearer at the stump support during construction and additional steel beams were installed under the house for stability (See Figure 32 and Figure 35).

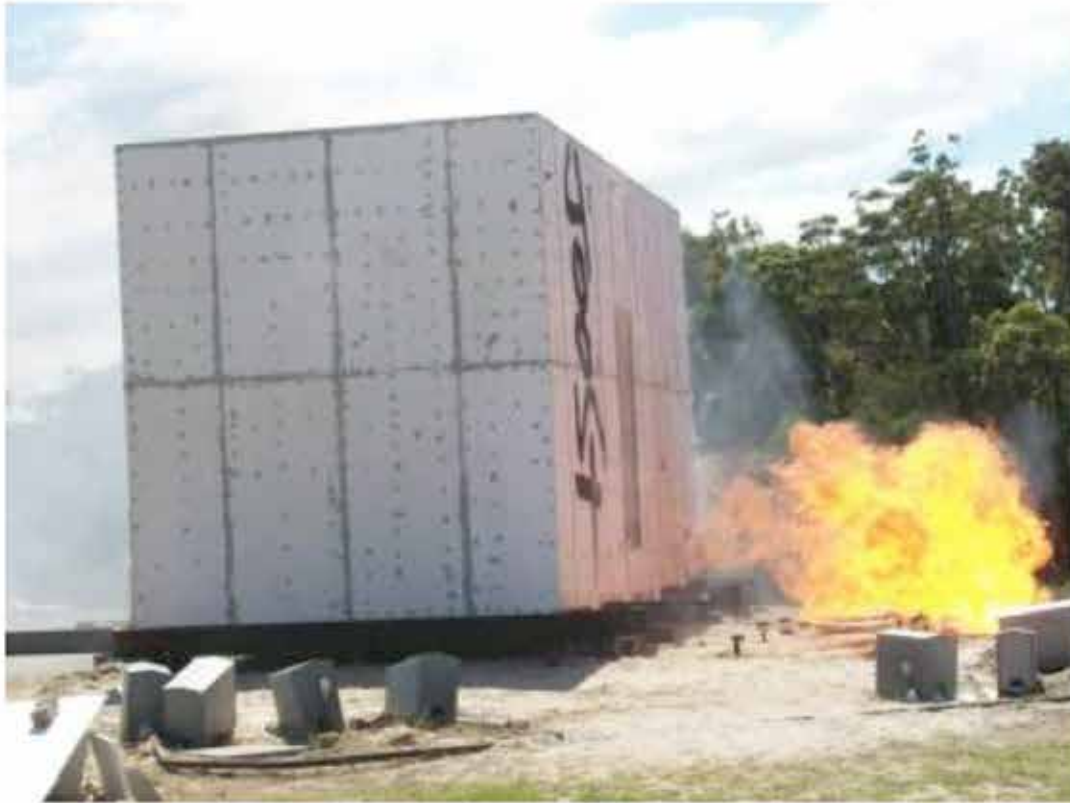
Figure 21 House during the radiant heat exposure phase

The pre and post fire front radiant heat is provided by a single row of burners set on the ground a small distance from the front of the house as shown in Figure 21. The timing of the test is matched to the weather conditions to ensure the heated air from the burners is blowing towards the house.

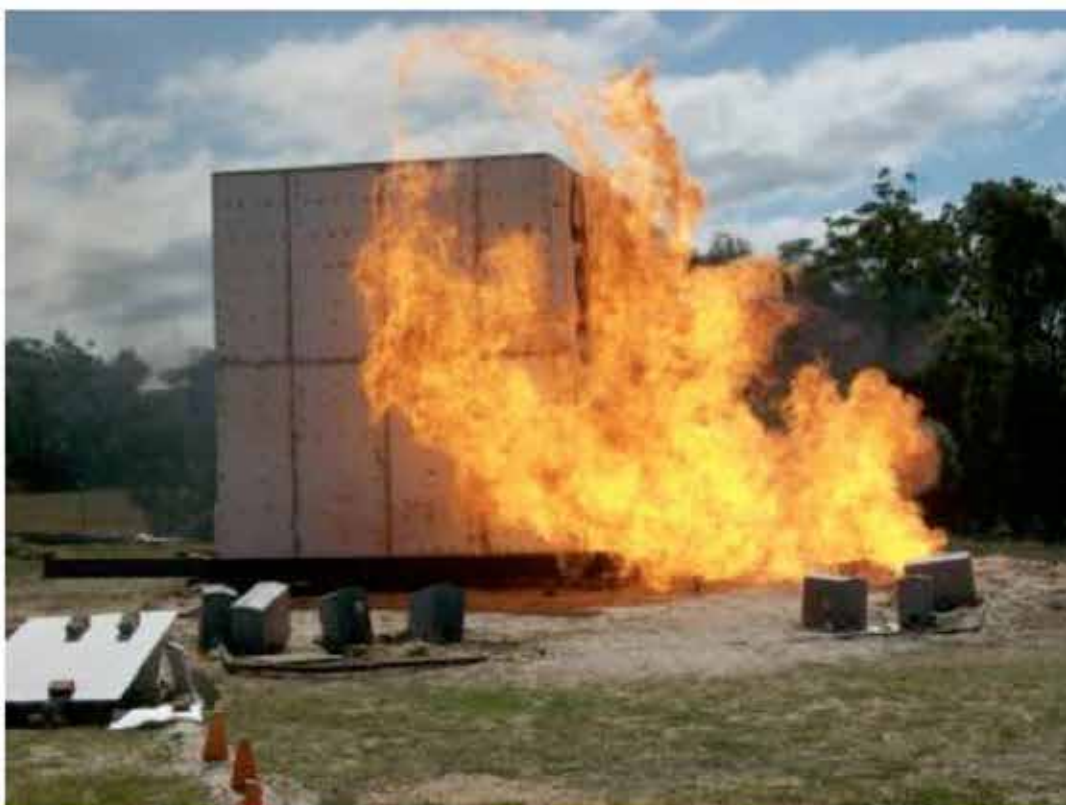
Figure 22 House during the flame immersion phase

The flame immersion stage uses a grid of burners in front of the house (including some right next to the house) as shown in Figure 22. The flames spread under, over and around the house.

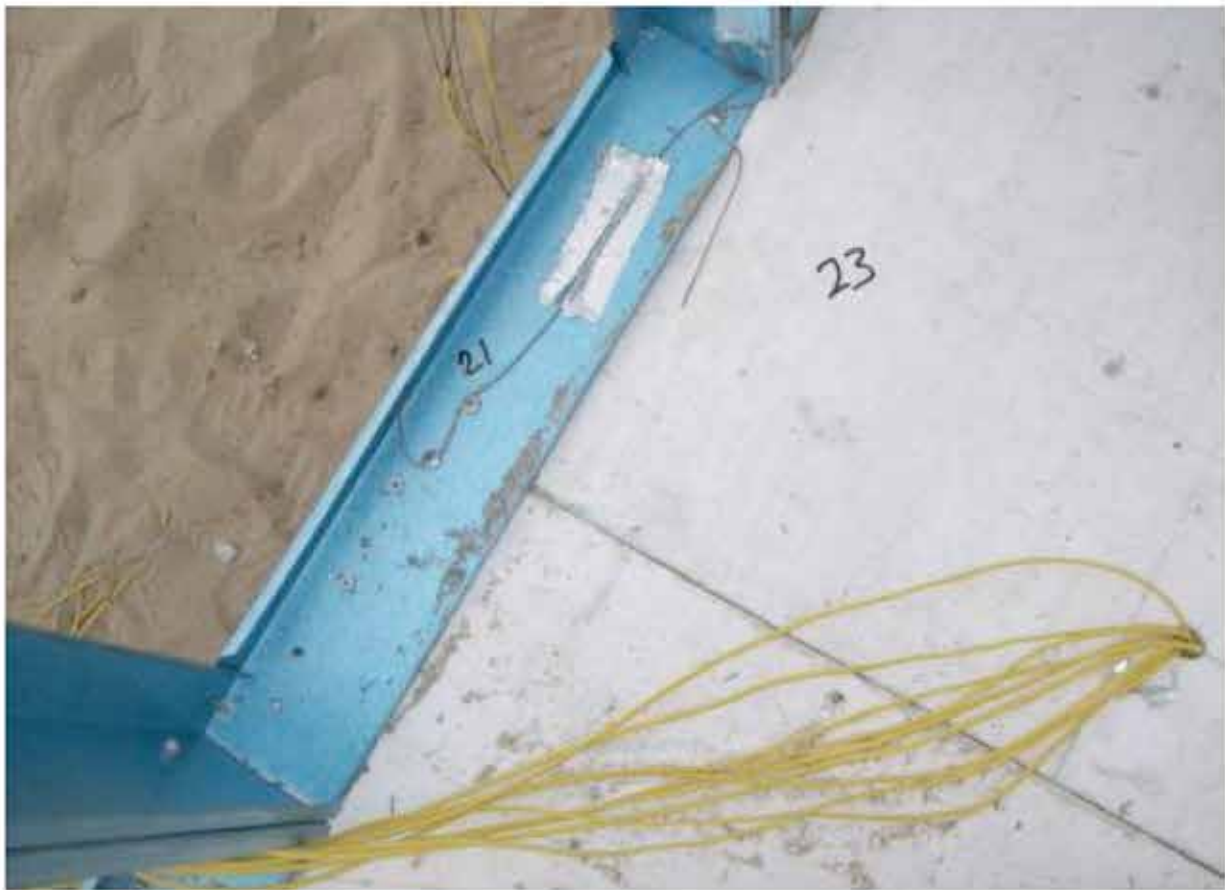
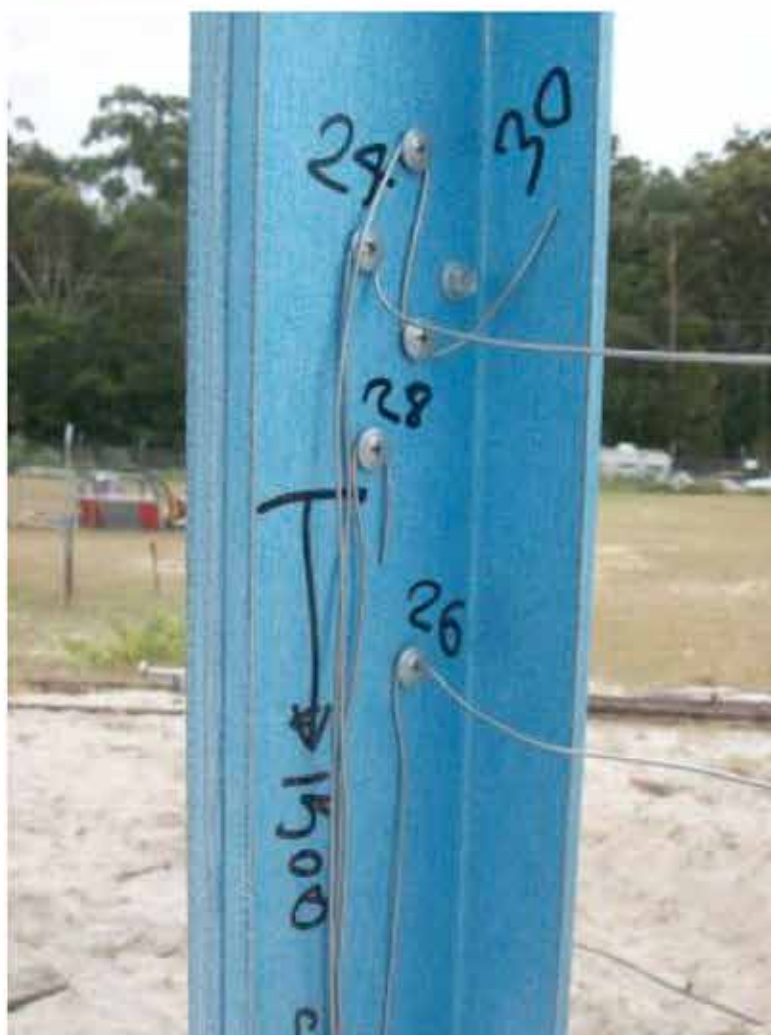
Figure 29 Examples of thermocouples used for measuring surface temperatures

(#21 bottom plate flange, # 28 stud web, #30 stud flange )

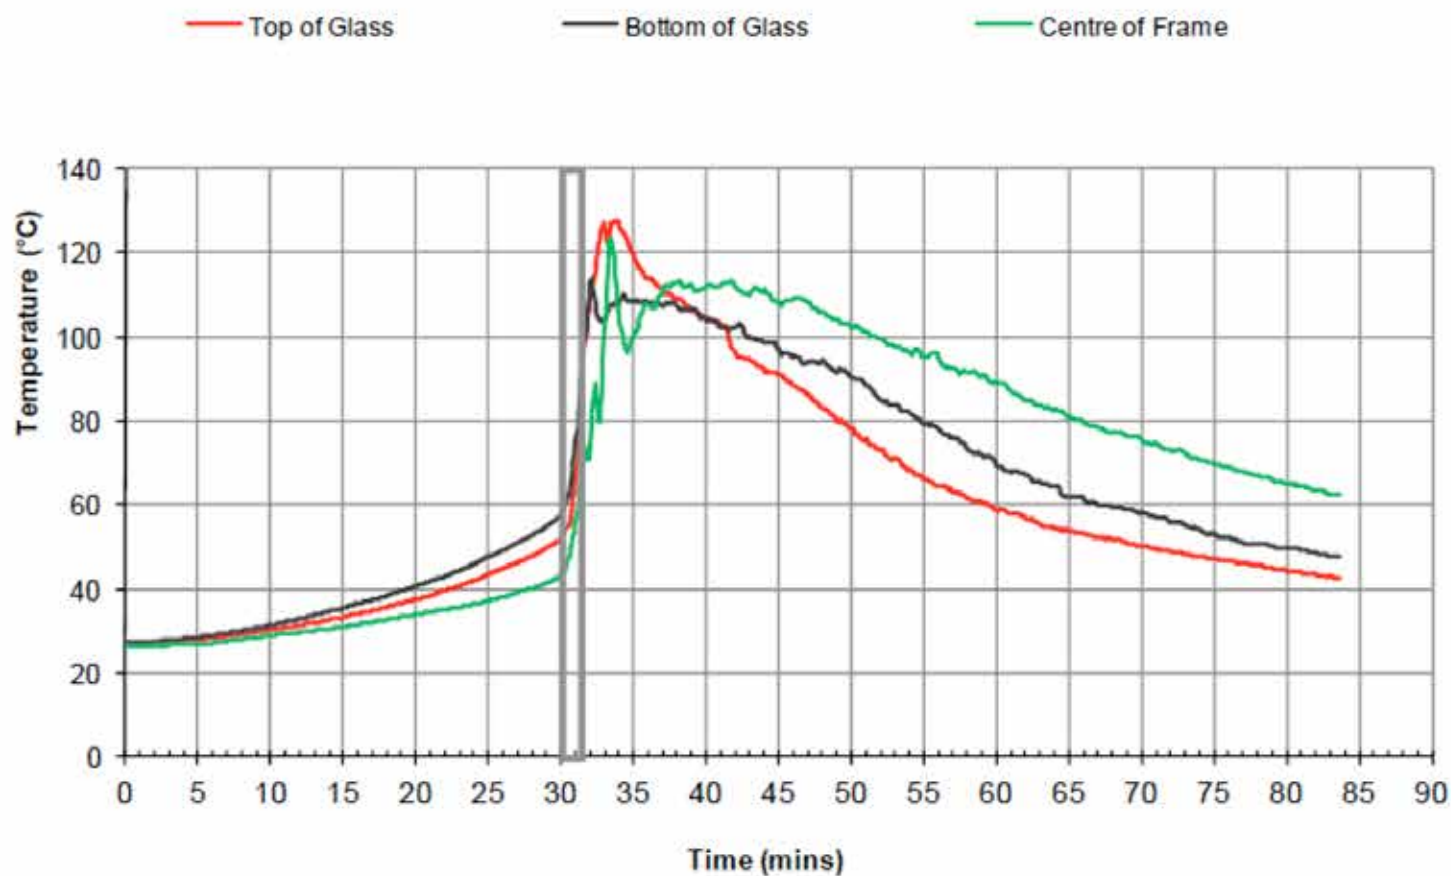
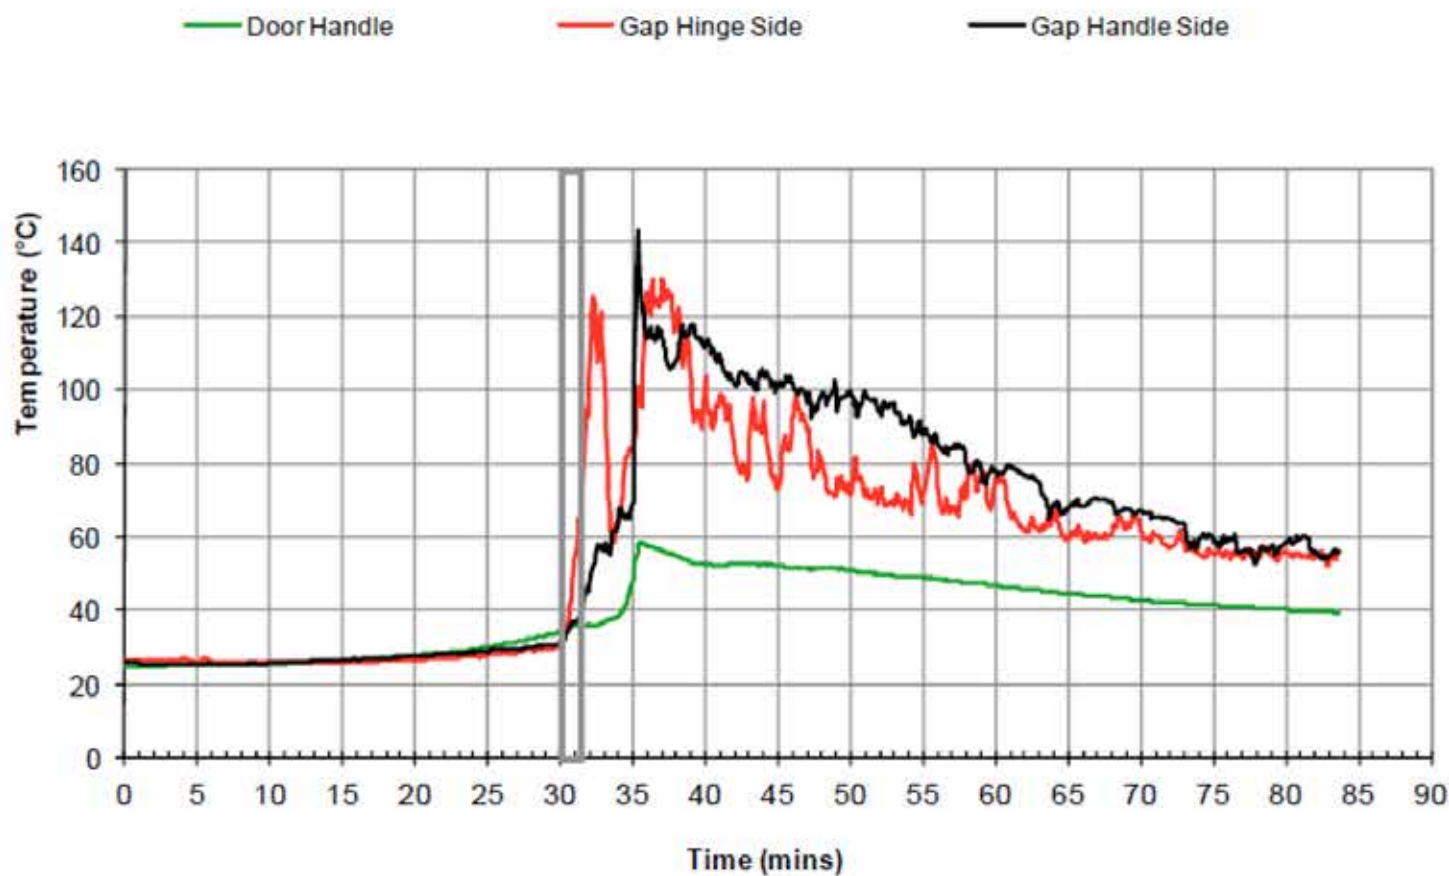
Figure 64 Temperatures on inside of the door

Plots of the temperatures are shown in Figure 63 and Figure 64.

- The outside glass temperature (**green** in Figure 63) increases at a faster rate than the air temperature reaching  $\sim 250^{\circ}\text{C}$  or approximately  $100^{\circ}\text{C}$  higher than the air temperature just before the flame immersion phase.

- The outside glass, frame and air temperatures are  $\sim 900^{\circ}\text{C}$  during the flame immersion phase.
- The outside bottom glass temperature drops rapidly 15secs after the start of the flame immersion phase. This is likely due to the outside glass pane of the door failing and dislocating the thermocouple.

- The inside glass temperature reaches a maximum of  $\sim 130^{\circ}\text{C}$ , occurring more than a minute after the flame immersion phase began. During the flame immersion phase the temperature is less than  $80^{\circ}\text{C}$ .

- The inside temperature of the steel door frame and the glass have a very similar temperature profile over the duration the test.
- The door handle temperature reaches a maximum temperature of  $\sim 60^{\circ}\text{C}$ , 3 minutes after the end of the flame immersion.

- The inside air temperature in the gap between the door and the frame increases rapidly on the hinge side towards the end of the flame immersion. This may be due to hot air entering the gap or to the thermocouple coming into contact with the door due to deformation of the door/frame. The air temperature in the gap on the handle side increases rapidly after the flame immersion phase to  $\sim 70^{\circ}\text{C}$ , 3 minutes after flame immersion then instantly jumps to  $\sim 120^{\circ}\text{C}$ . This is probably due to the thermocouple coming into contact with the door due to deformation of the door/frame. Both temperatures then follow the same decline as for the inside glass and frame of the door.

- At the end of the test (45minutes) the temperatures are in decline.

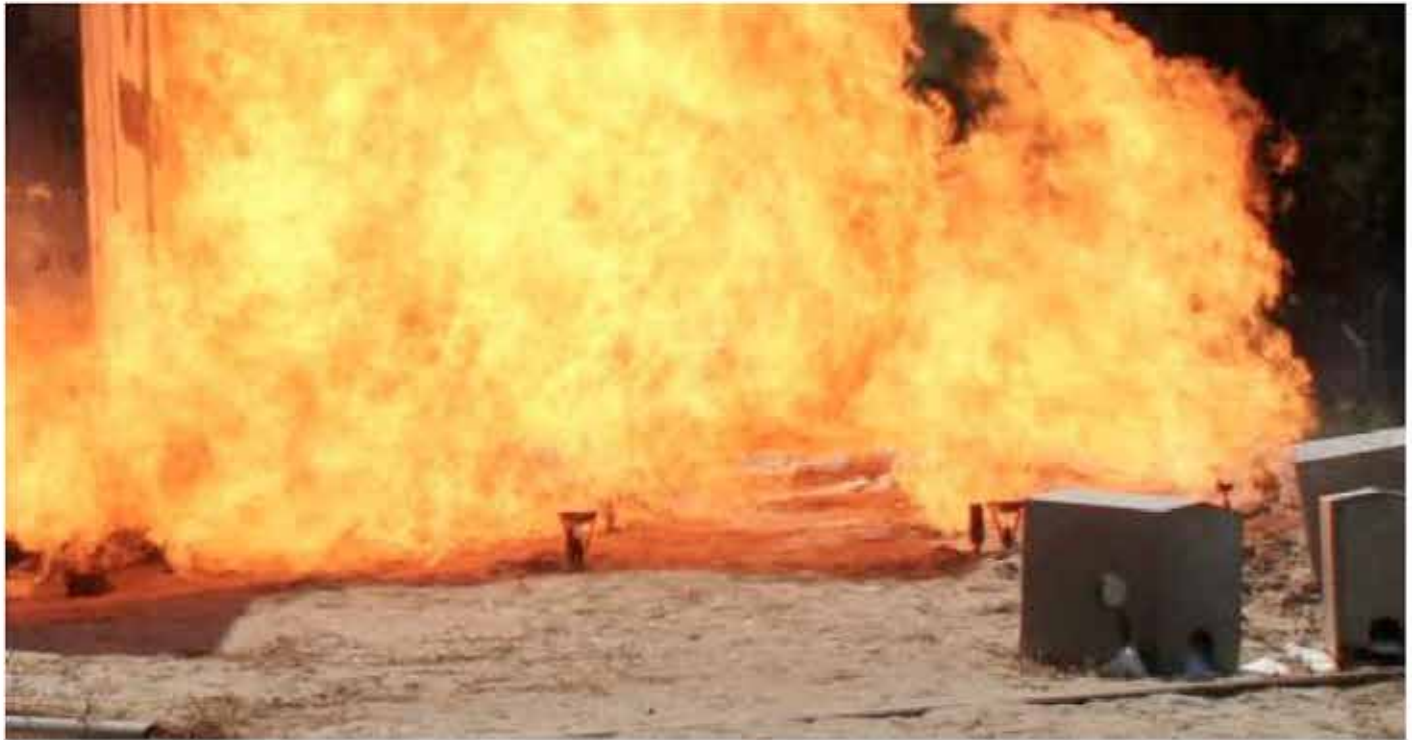
Figure 24 Gas delivery from main grid burners

Burner nozzles used are mounted on 150 mm vertical stems off the manifolds. This allows the manifolds to be covered with sand to a depth of 50 to 100 mm for heat insulation. Brass jets, appropriately sized for each test, can be quickly screwed in as needed. For the purpose of flame shaping, each burner has a convex-down deflector approximately 150 mm in diameter mounted 150 mm above the jet, see Figure 24. For this experiment the burner nozzles delivered at approximately 16 MW/m of fire line, which was considered sufficient to create flame significantly taller than the house hence effectively immerse it, high gas flow rate will have produce a larger flame body but is unlikely to have resulted in a more severe direct exposure to the house with the excess heat energy being expressed well above the house.

The burners are ignited by pilot flames that are lit prior to the start of the test.
