Fire-resistance test on a load-bearing vertical separating element

Test Report

Author: Chris Wojcik
Report number: FSV 1708B
Date: 7 March 2016
(This report supersedes issue dated 24 November 2015)

Sponsored Investigation No. FSV 1708B

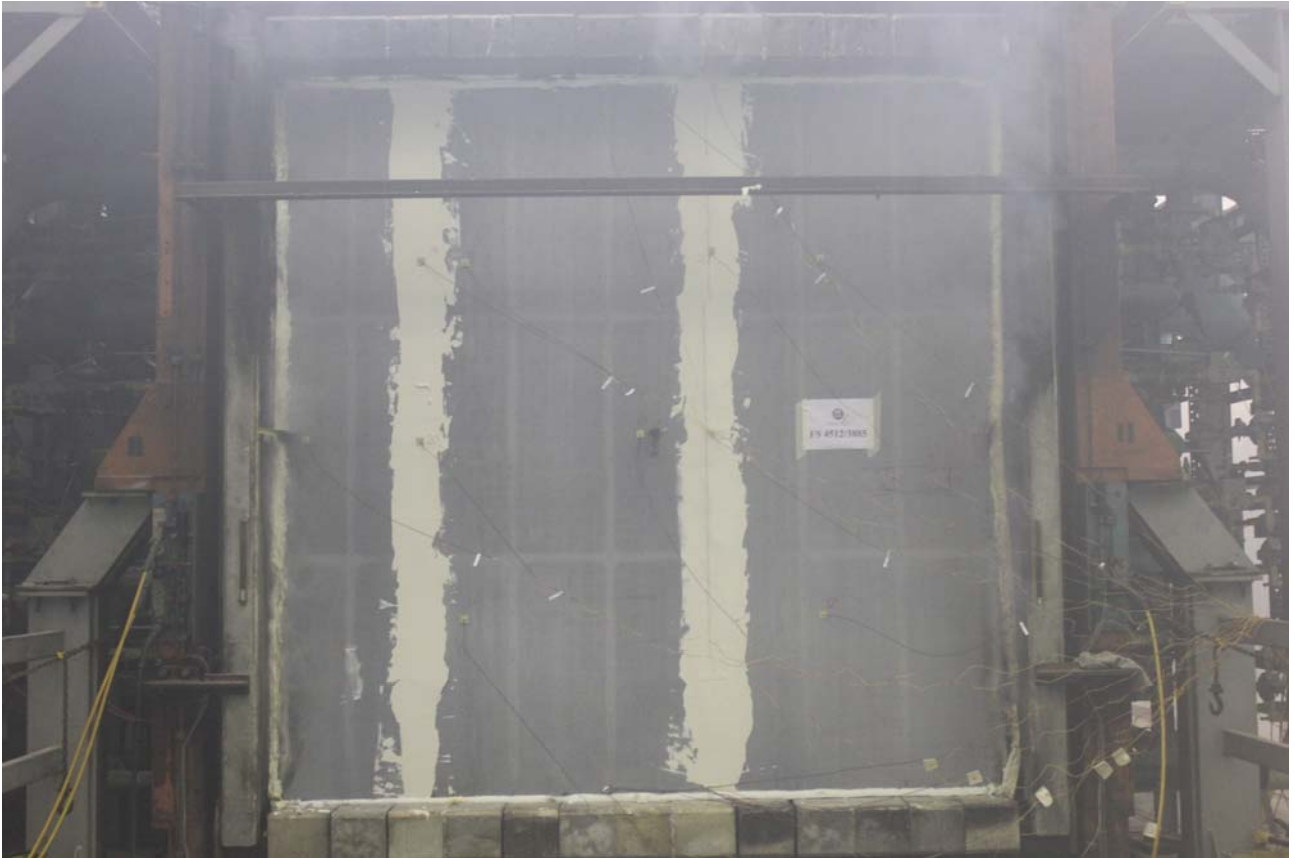
PHOTOGRAPH 5 – SPECIMEN AT 60 MINUTES INTO THE TEST

- 6 minutes - Smoke is emitted from along the perimeter of the wall.
- 28 minutes - Amount of smoke emitted from the specimen has increased.
- 30 minutes - A crack has developed in the stopping along the right board joint (photograph 4).
- 50 minutes - Steel framing outline is visible on the unexposed face of the wall (photograph 5).
- 66 minutes - Glow is visible through the crack noted at 30 minutes (photograph 6).

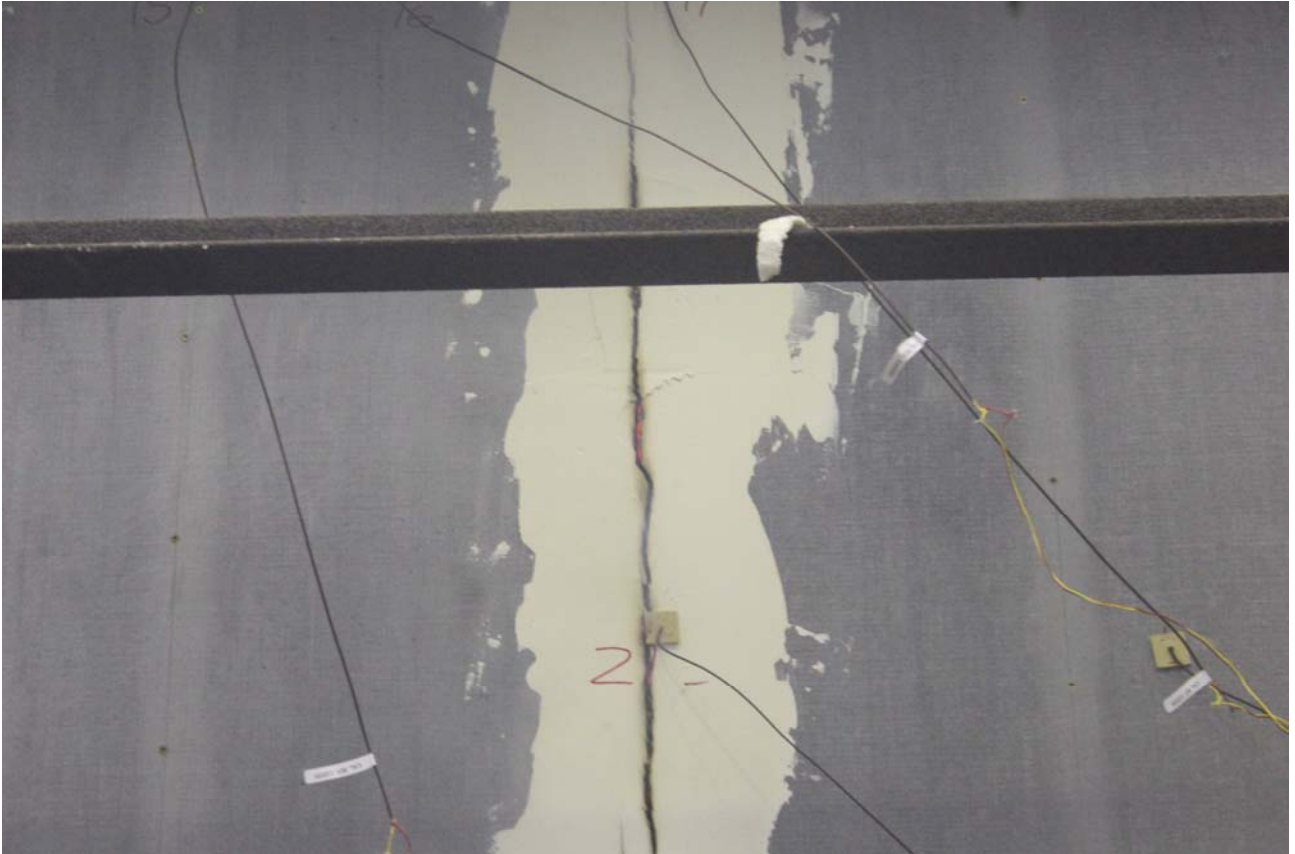
PHOTOGRAPH 6 – SPECIMEN AT 71 MINUTES INTO THE TEST

- 70 minutes - Cotton wool pad test applied over the glowing joint noted at 66 minutes – no ignition of cotton noted.
- 74 minutes - Integrity failure - cotton wool pad test applied over the glowing joint noted at 66 minutes – ignition of cotton noted.
- 76 minutes - Insulation failure – maximum temperature rise limit of 180 deg Celsius is exceeded on the unexposed face of the wall, adjacent to the cracked panel joint at $\frac{3}{4}$ height.

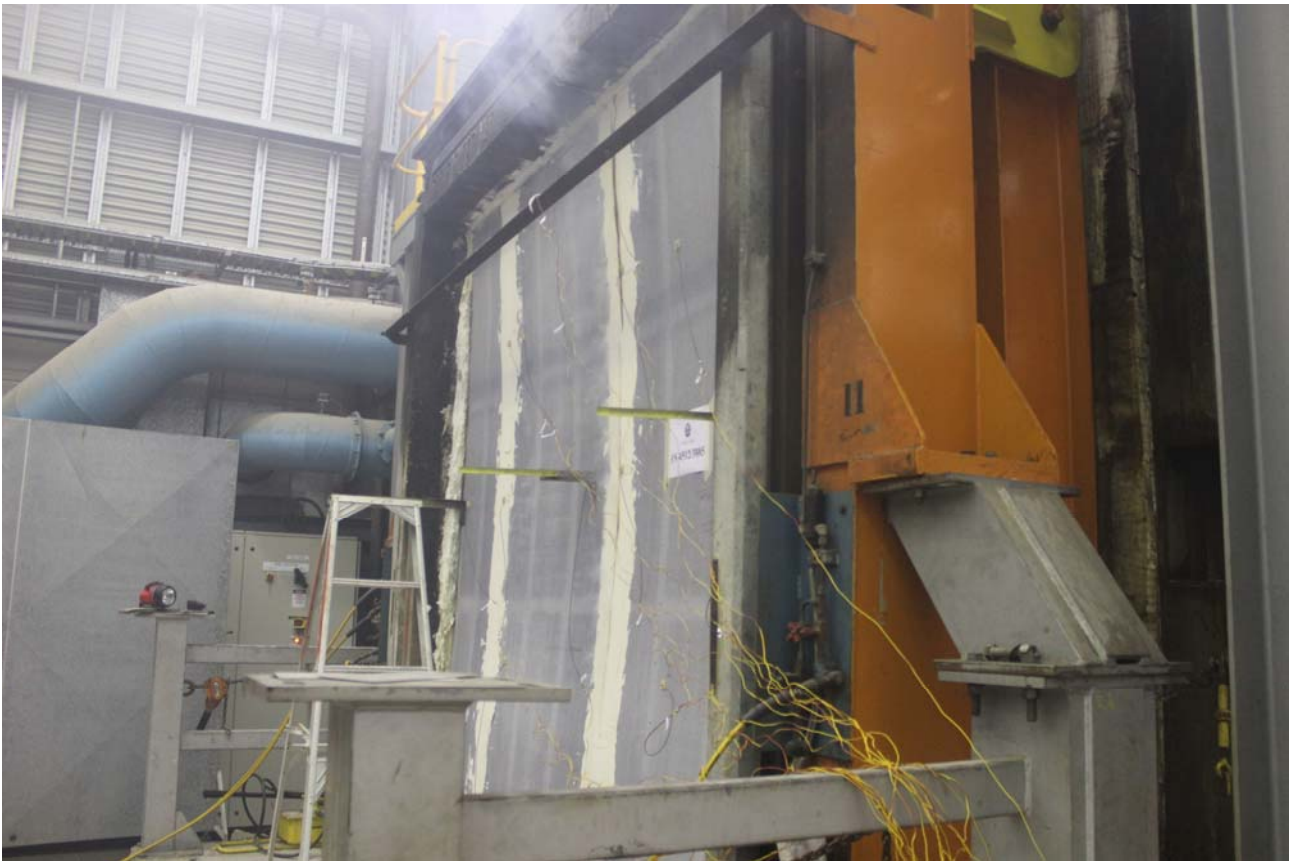
PHOTOGRAPH 7 – SPECIMEN AT 76 MINUTES INTO THE TEST

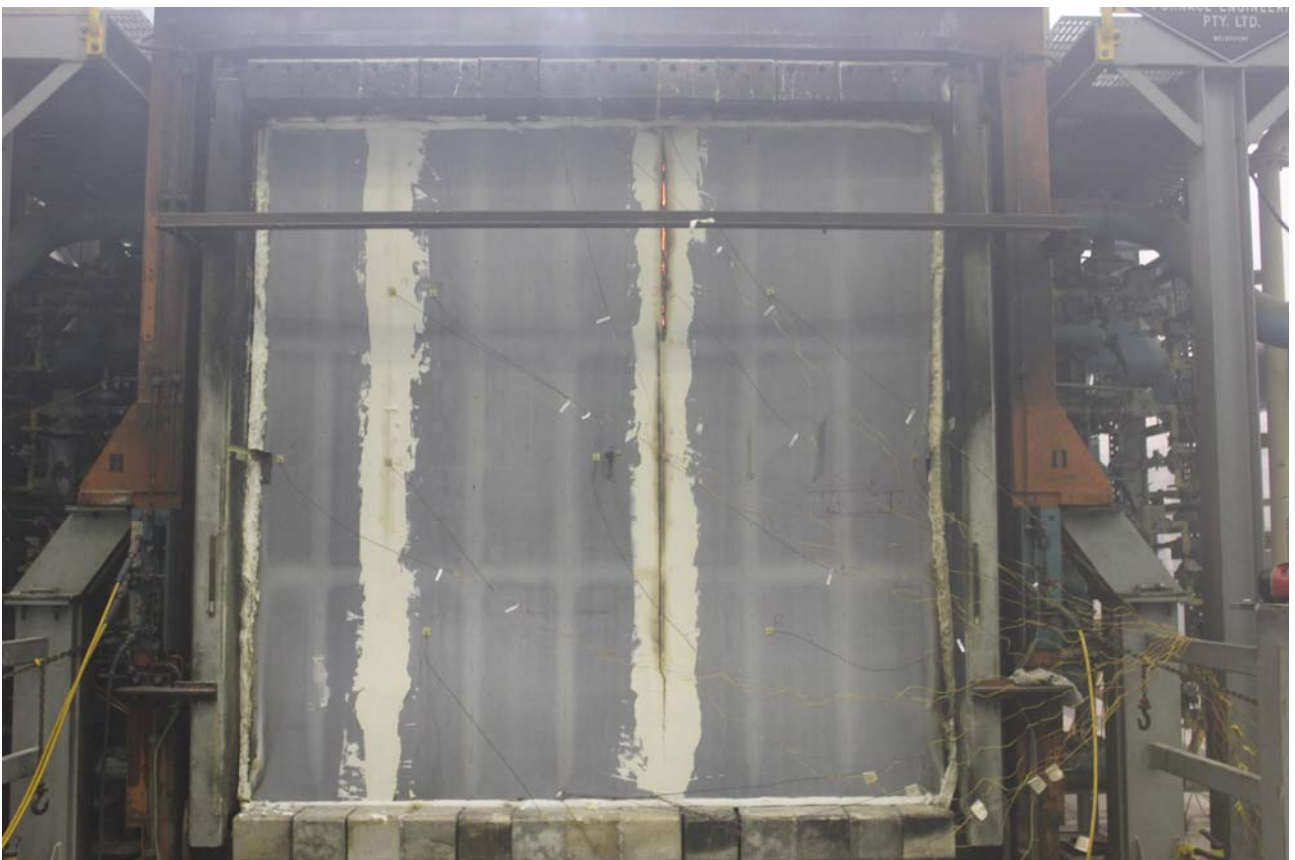
PHOTOGRAPH 8 – SPECIMEN AT THE CONCLUSION OF TESTING

Joint stopping material is starting to discolour along the crack noted at 30 minutes.
- 90 minutes - Crack along the panel joint noted at 70 minutes is approximately 6-8-mm in width (photograph 8).
- 93 minutes - Test terminated.
