Test Report – Fire Resistance:

TESTING PERFORMED ON: A steel framed, stud wall with one layer of R2.5 x 90mm thk earthwool and sheeted with a dual layer of 10mm thk SE FireCrunch board each side.

TEST DATE:	05/09/2018
REPORT WRITTEN BY:	M. Lewis
REPORT DATE:	13/09/2018
RTL REPORT NO:	TR-F026.01 (PR0057)
TEST ID:	FR34.S3/2018
SCOPE:	Measurement of fire resistance in general accordance with AS 1530.4-2014 Sections 1, 2 and 3

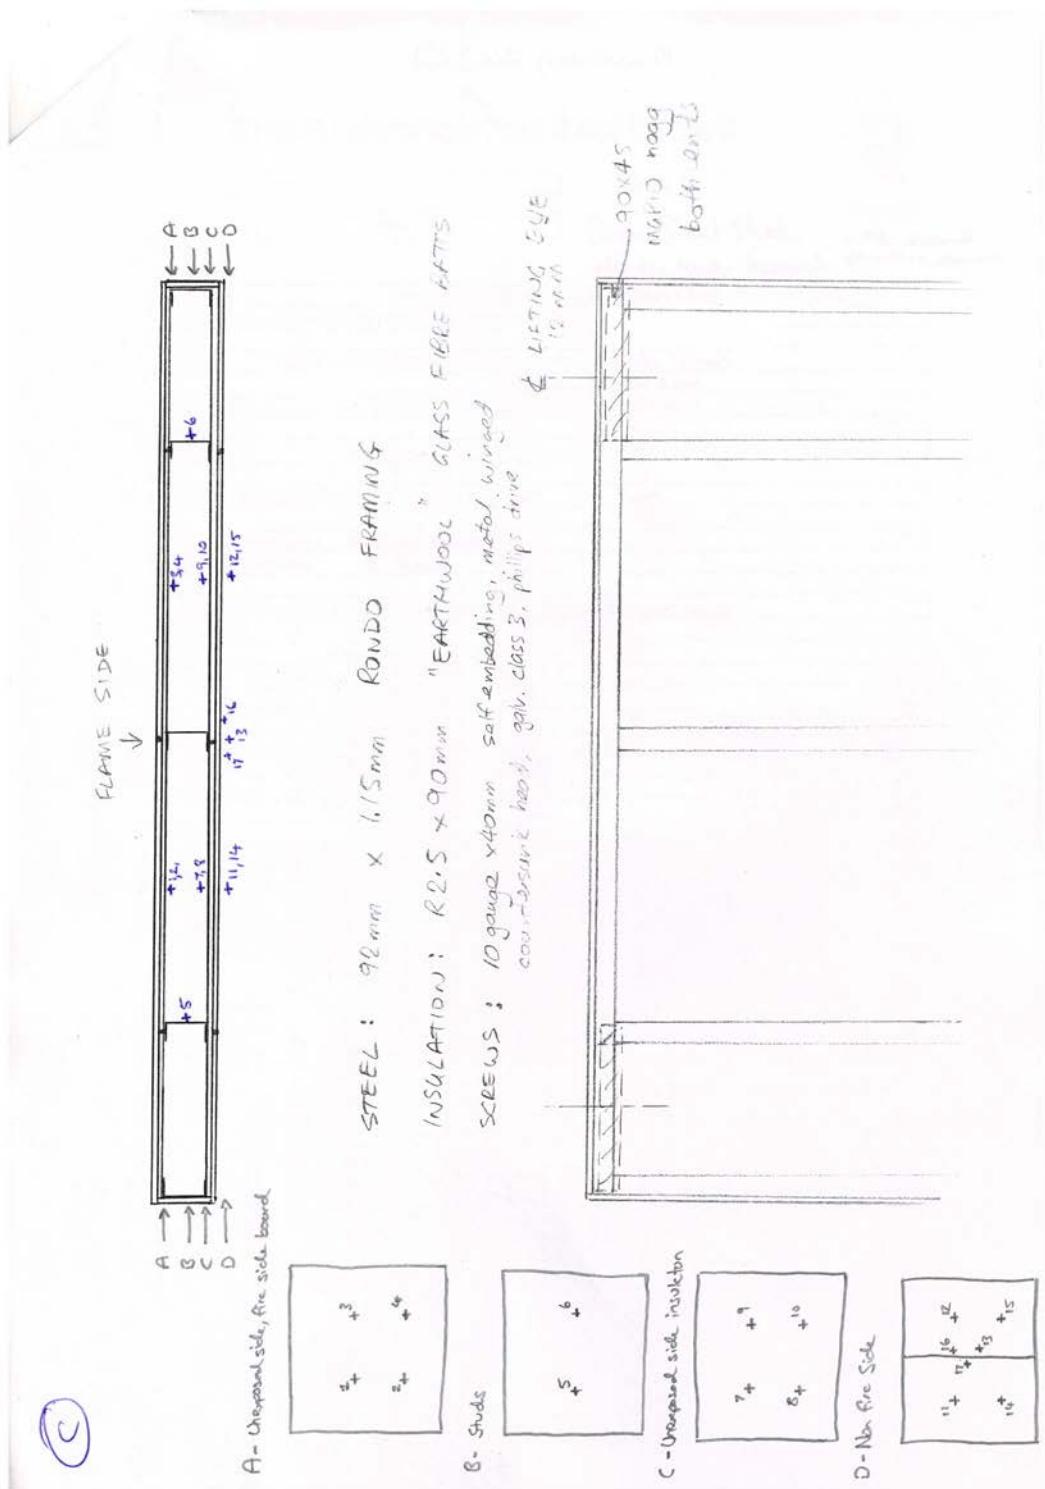
Drawing 1 – Client supplied drawing. Lab added TC locations

1X 92 X 45MM SINGLE STEEL STUD FRAME 1.15BMT
2 X10MM FCA SHEETS EACH SIDE
1 POWER POINT AND FIRE BOX EITHER CLIPSAL OR HPM EXPOSED SIDE
INSULATION R2.5 GLASS WOOL BATT 90MM
AS1530.4 FIRE SEALANT, BOSTIK FIRE BAN TO JOINTS AND PERIMETERS
SEALANT IN 3X 3 MM BEADS DOWN EACH (VERTICAL) JOINT 45MM STUD FACE
4MM FIRE GAP BETWEEN VERTICALLY SET BOARDS FILLED WITH SAME FIRE SEALANT
FIXED WITH 10 GAUGE x 40MM SELF-EMBEDDING, METAL WINGED COUNTERSUNK HEAD, GALV CLASS 3 PHILLIPS
DRIVE AT MIN 200 CENTRES

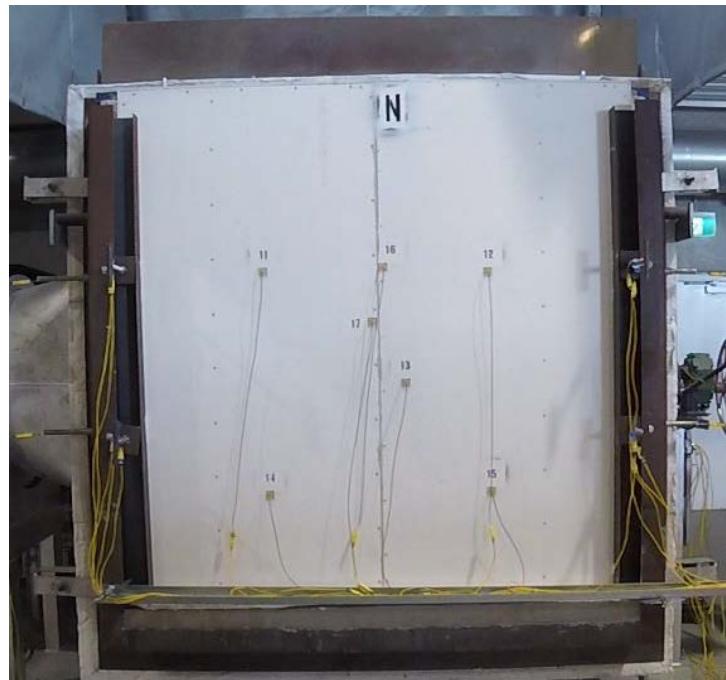
Photo 1 – Unexposed side at commencement of test

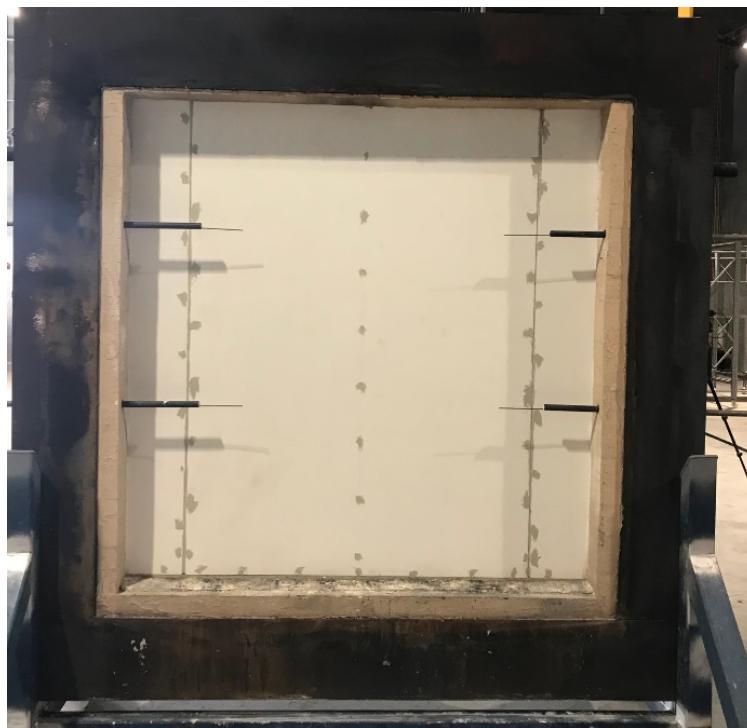
Photo 2 – Exposed side pre-test

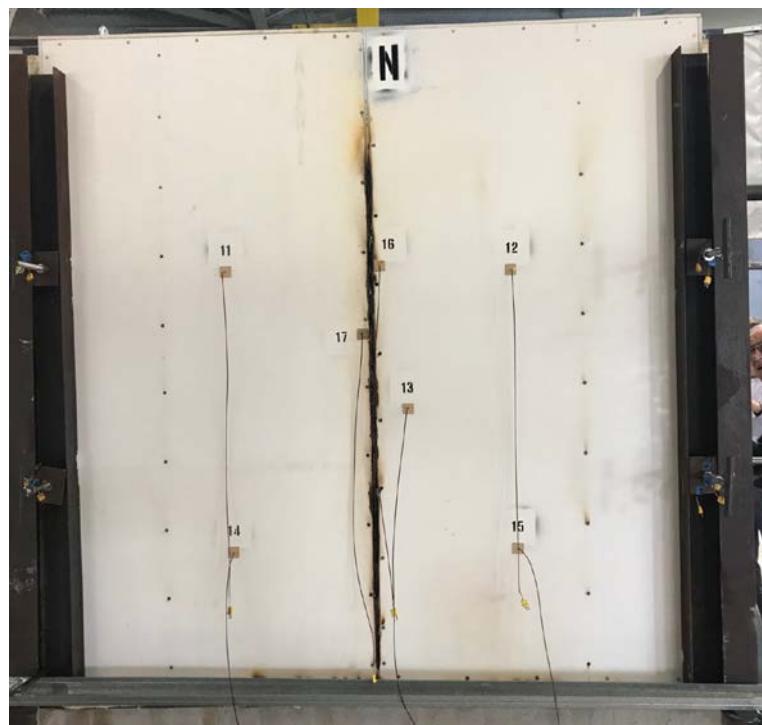
Photo 3 – Unexposed side post-test

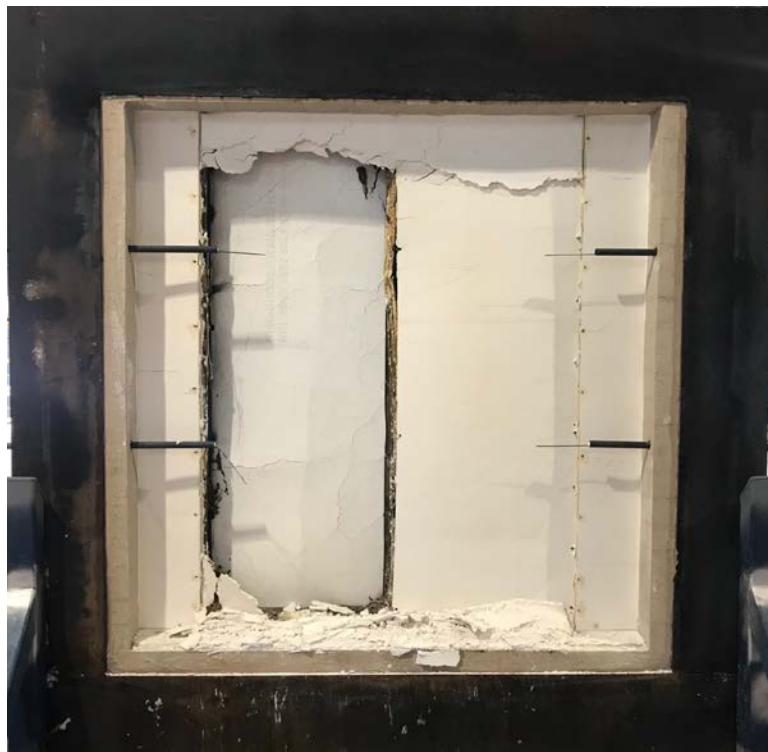
Photo 4 – Exposed side post-test
