Test Report – Fire Resistance:

TESTING PERFORMED ON: A timber framed, discontinuous double stud wall with two layers of R2.5 x 90mm thk earthwool and sheeted with a single layer of 10mm thk SE FireCrunch board each side.

TEST DATE:	03/09/2018
REPORT WRITTEN BY:	M. Lewis
REPORT DATE:	17/09/2018
RTL REPORT NO:	TR-F024.01 (PR0057)
TEST ID:	FR32.S3
SCOPE:	Measurement of fire resistance in general accordance with AS 1530.4-2014 Sections 1, 2 and 3

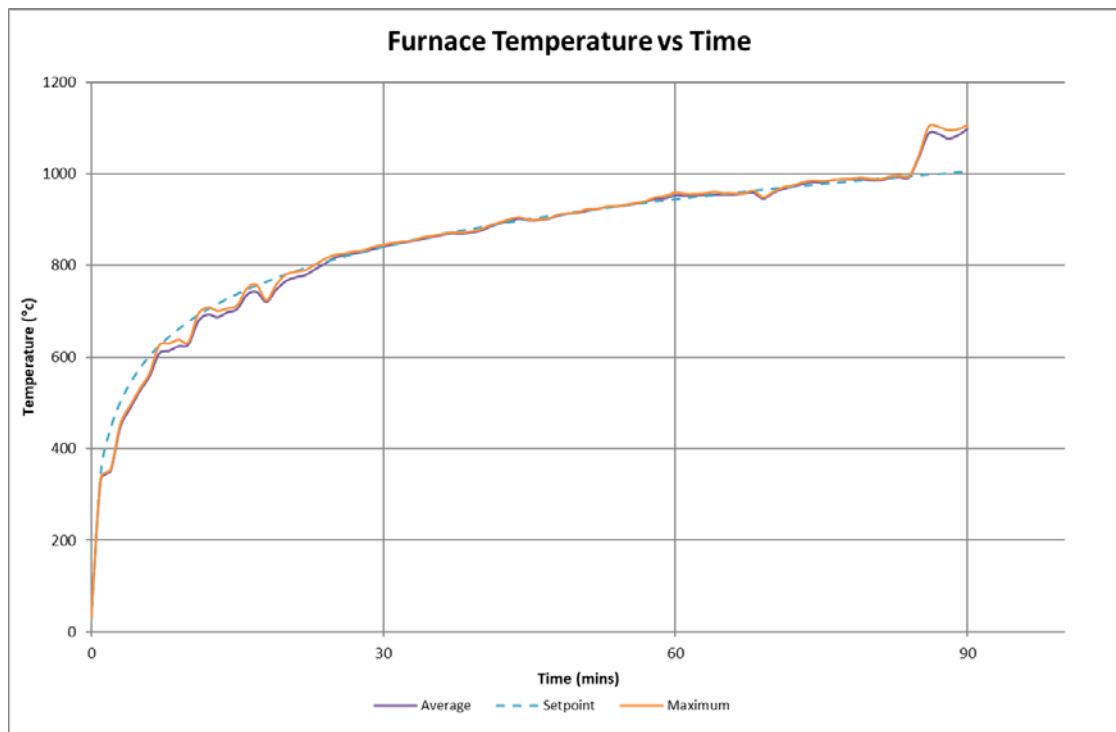
Figure 1 – Furnace Temperature

Furnace Heating Conditions – Temperature Curve

The temperature of the furnace shall be controlled to vary with time, as close as possible, in accordance with the following relationship:

$$T = 345 \log_{10}(8t + 1) + 20$$

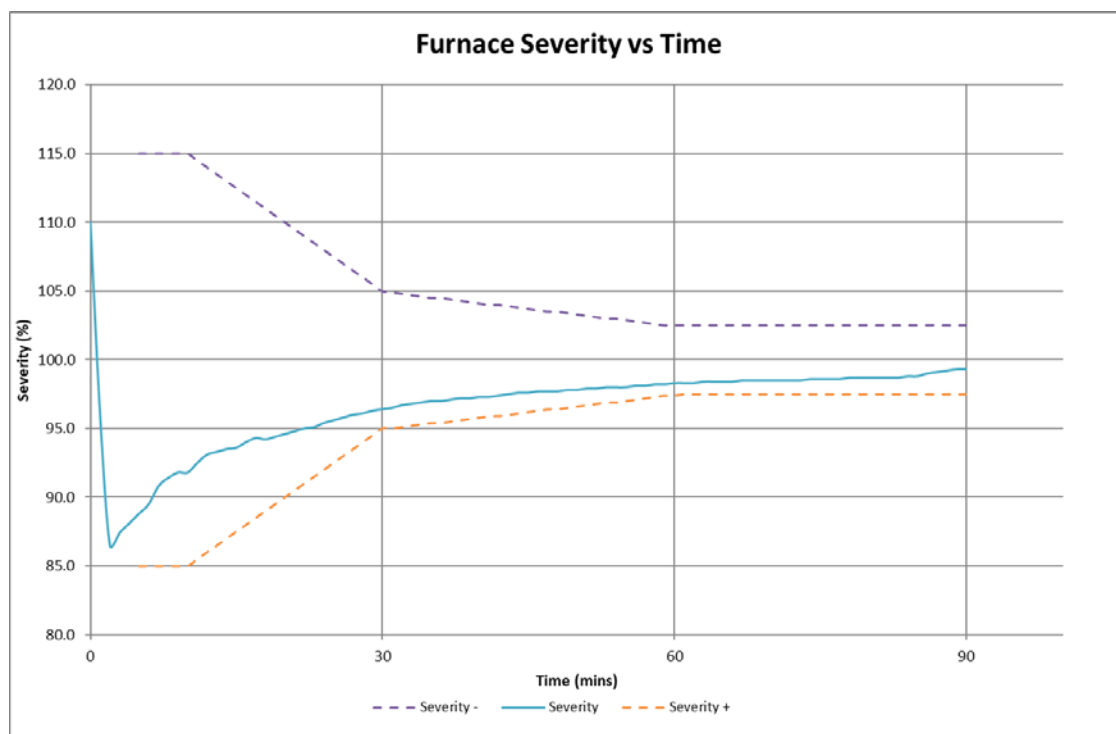
Figure 2 – Furnace Severity

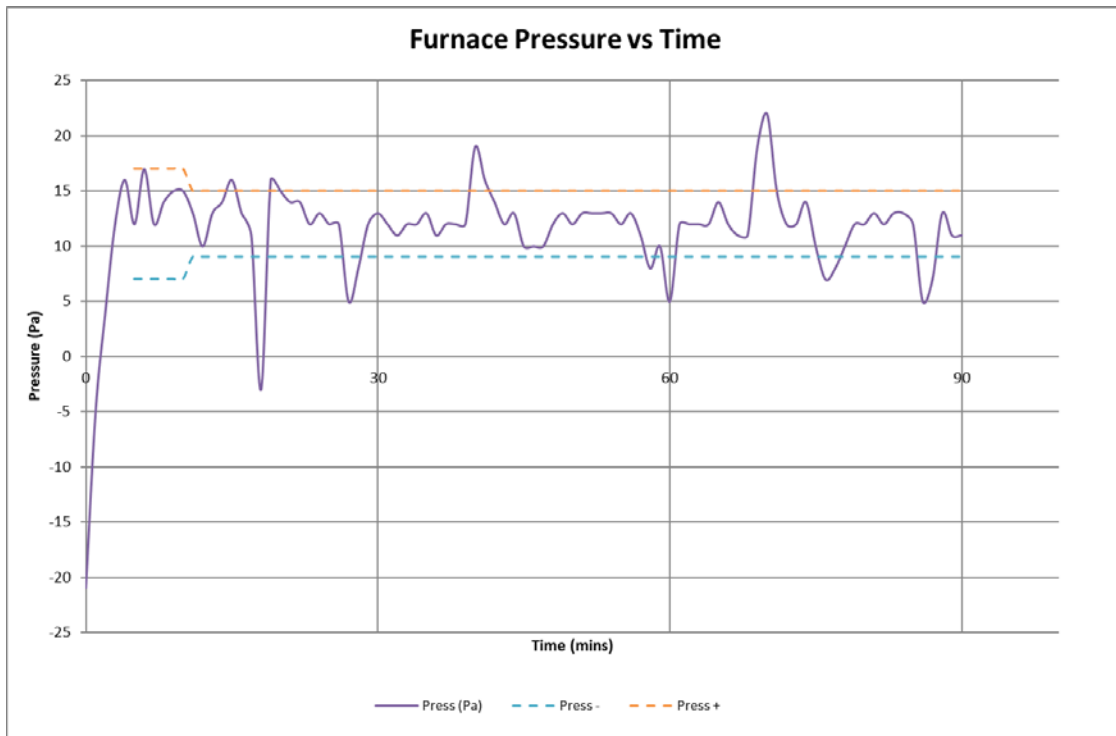
Figure 3 – Furnace Pressure

During the test the internal furnace pressure fluctuated outside of the control parameters intermittently.

Furnace Pressure Differential

Furnace pressure was measured with a Dwyer Magnesense pressure transmitter (S:N 71640), with a probe located 100mm from the face of the test specimen.

The pressure variations within the furnace chamber are not expected to have detrimentally affected the performance of the test.

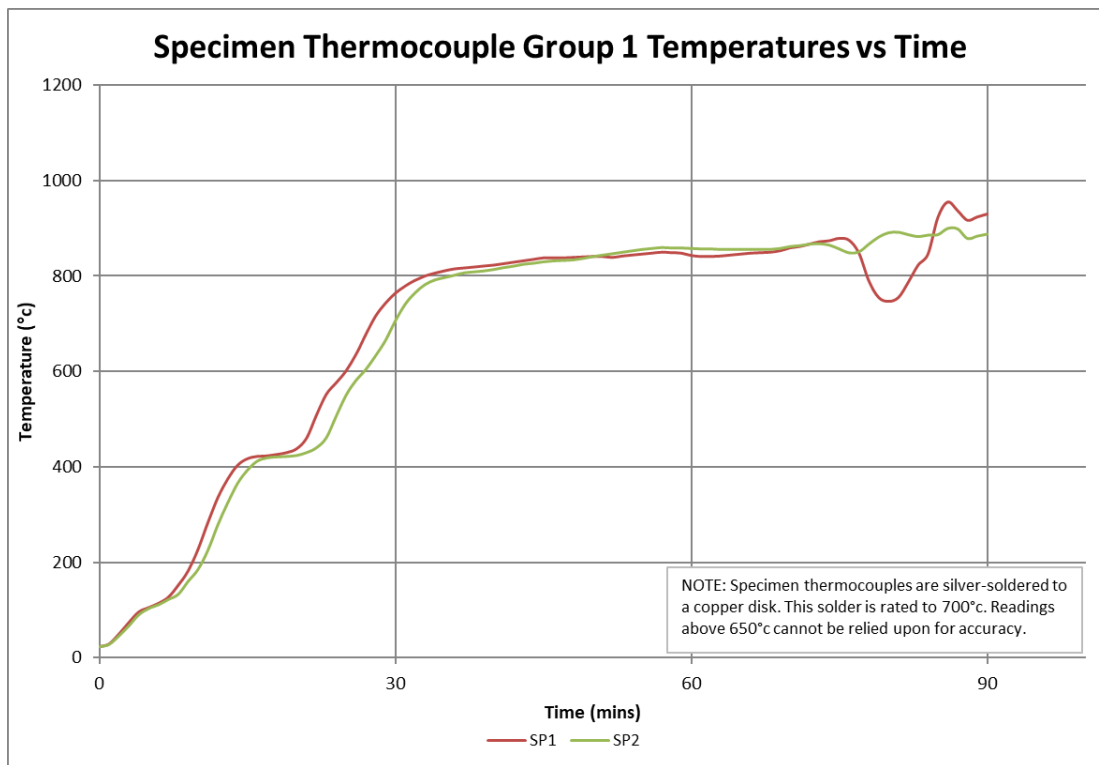
Figure 4 – Specimen Group 1 Temperatures

Table 2 – Specimen Group 1 Temperatures

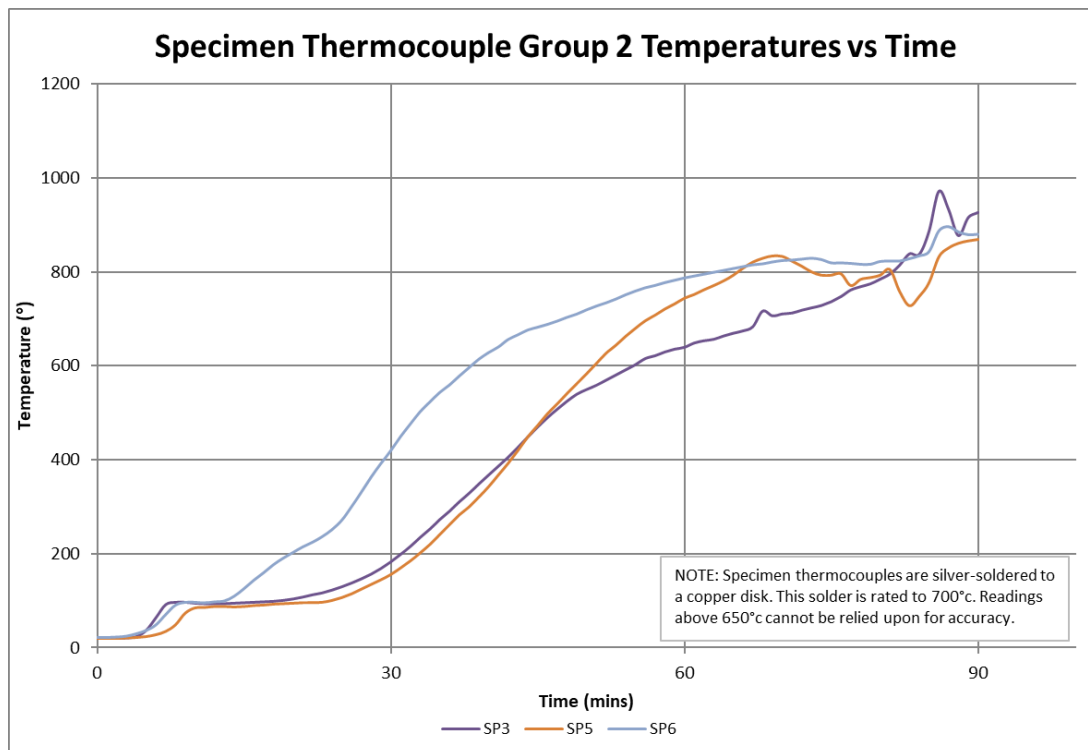
Figure 5 – Specimen Group 2 Temperatures

Table 3 – Specimen Group 2 Temperatures

*SP4 malfunctioned from the start of the test

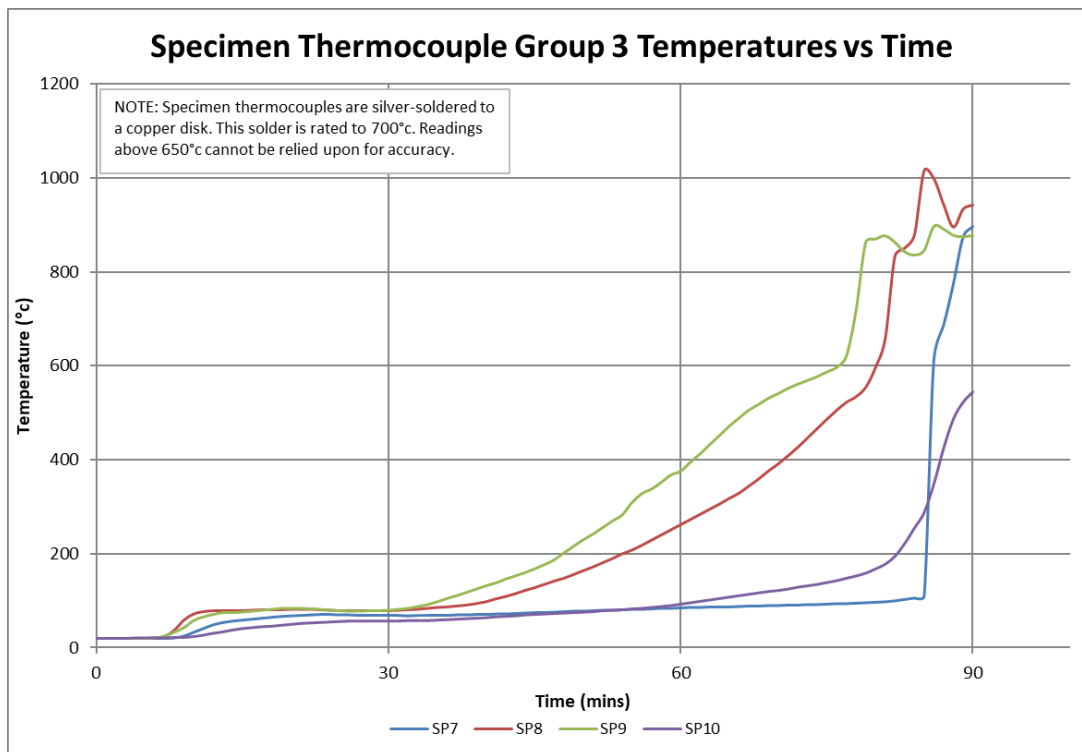
Figure 6 – Specimen Group 3 Temperatures

Table 4 – Specimen Group 3 Temperatures

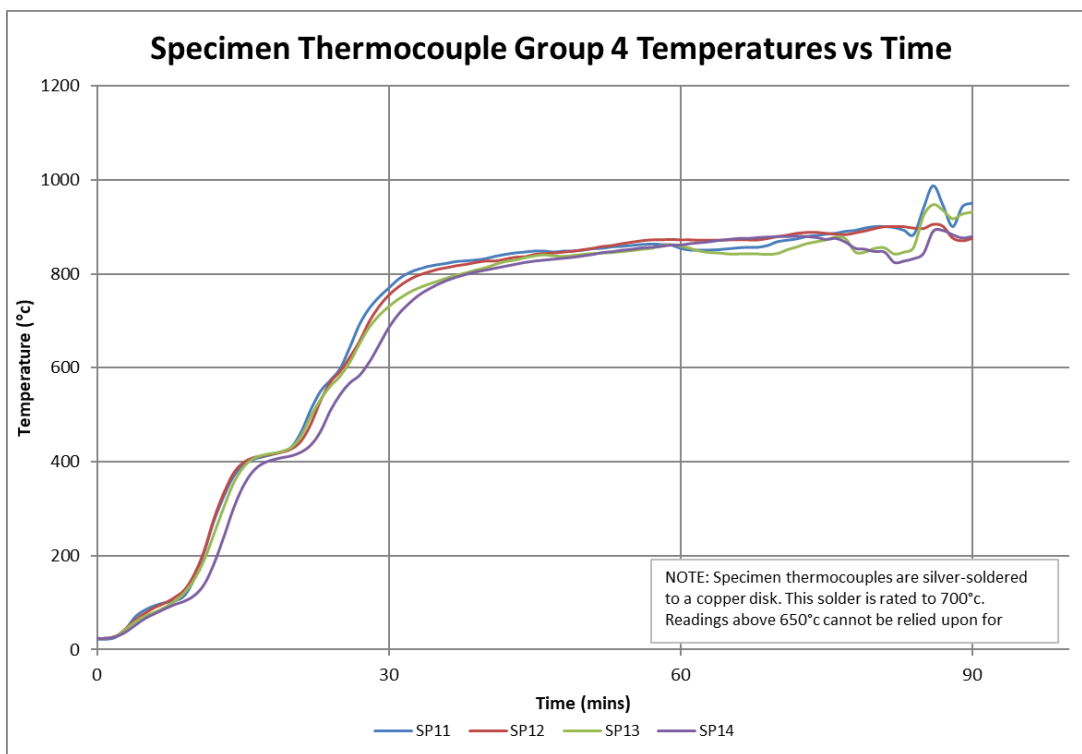
Figure 7 – Specimen Group 4 Temperatures

Table 5 – Specimen Group 4 Temperatures

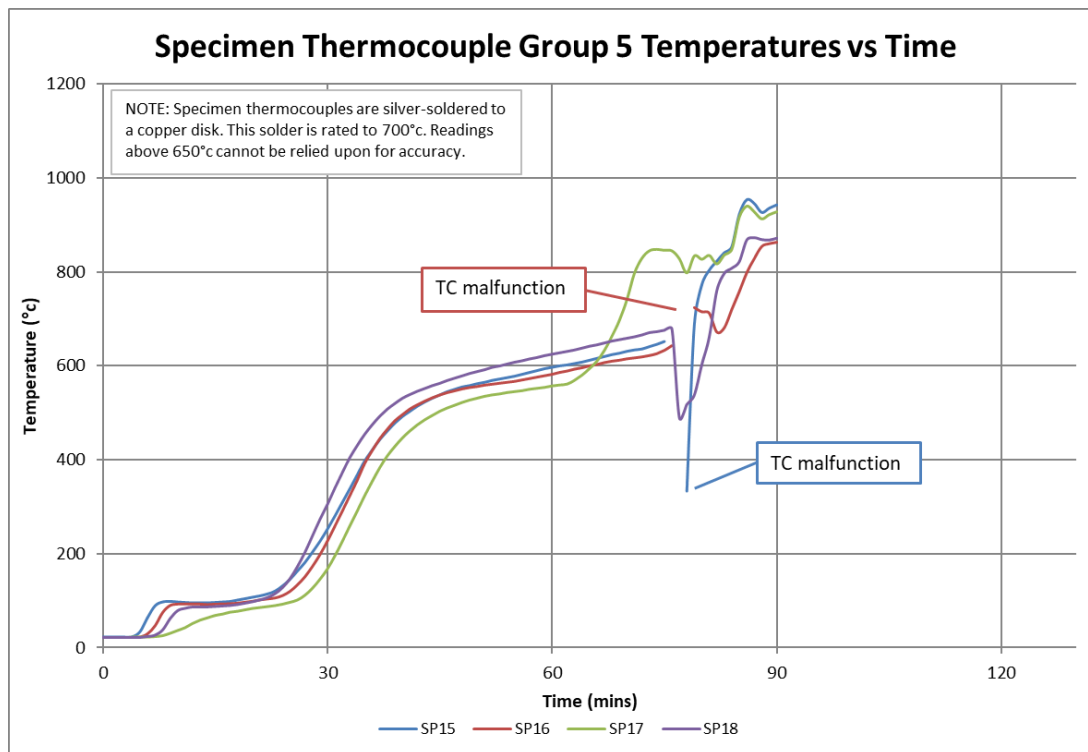
Figure 8 – Specimen Group 5 Temperatures

Table 6 – Specimen Group 5 Temperatures

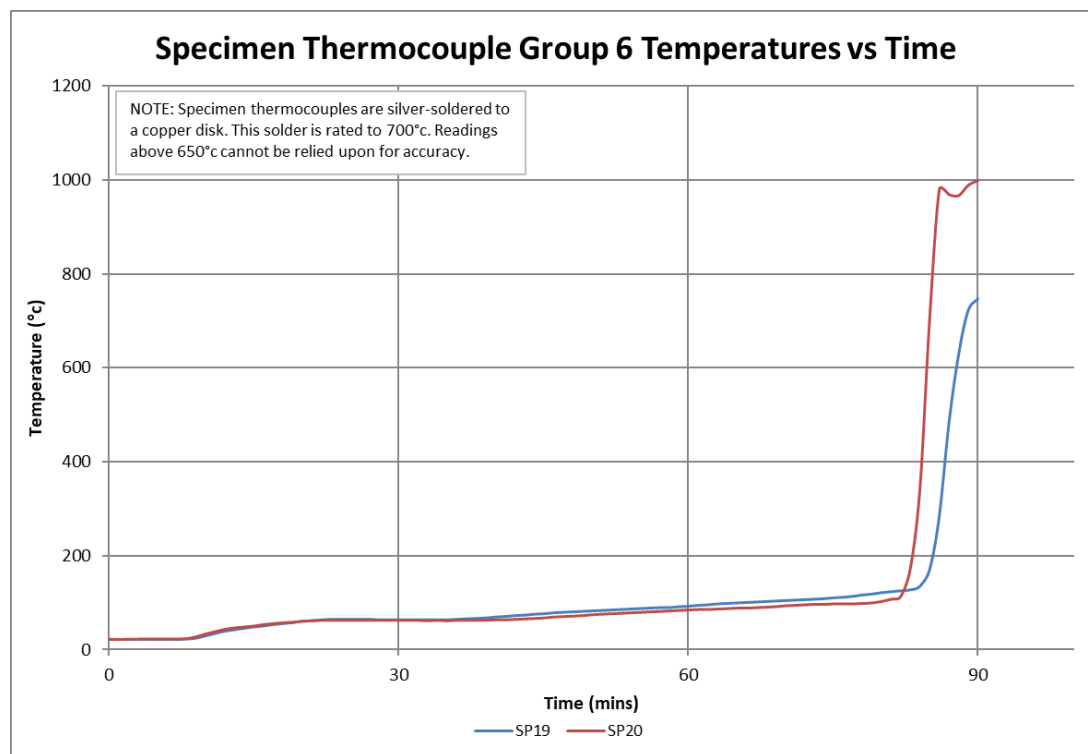
Figure 9 – Specimen Group 6 Temperatures

Table 7 – Specimen Group 6 Temperatures

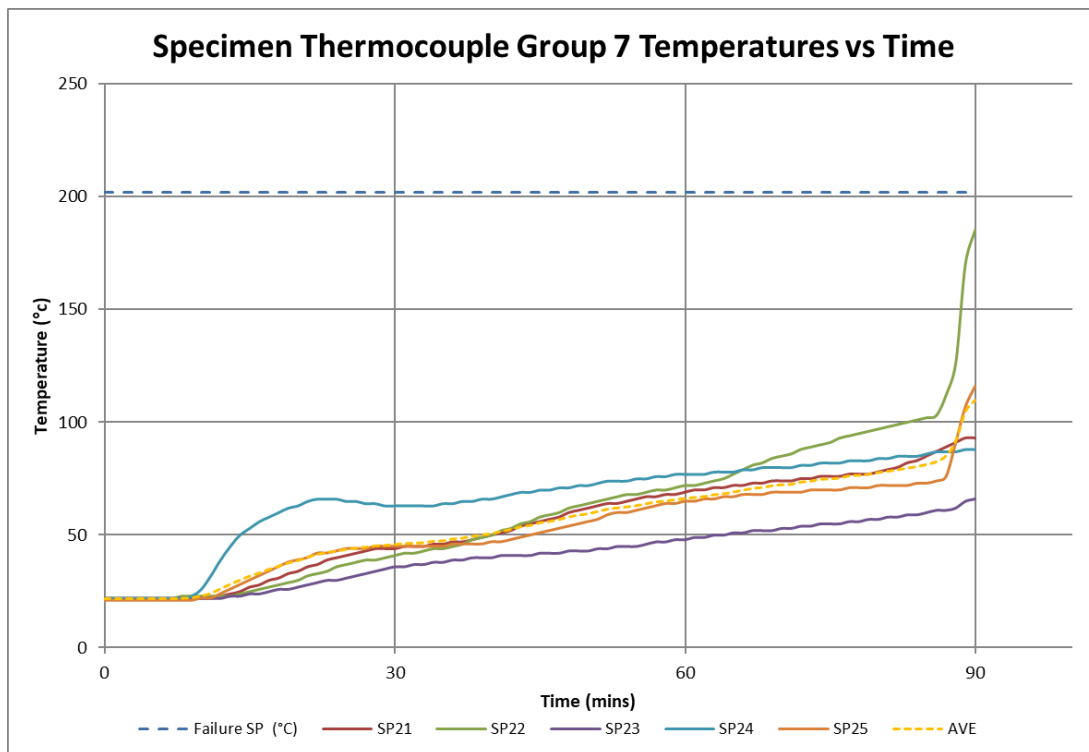
Figure 10 – Specimen Group 7 Temperatures

Table 8 – Specimen Group 7 Temperatures

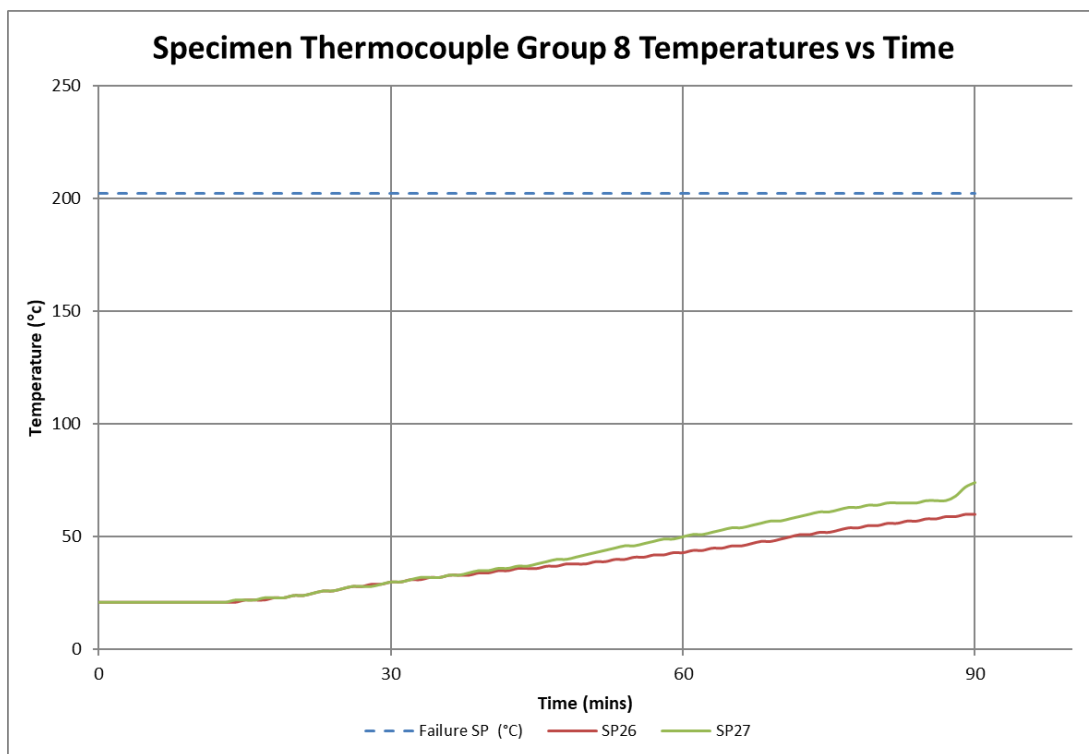
Figure 11 – Specimen Group 8 Temperatures

Table 9 – Specimen Group 8 Temperatures

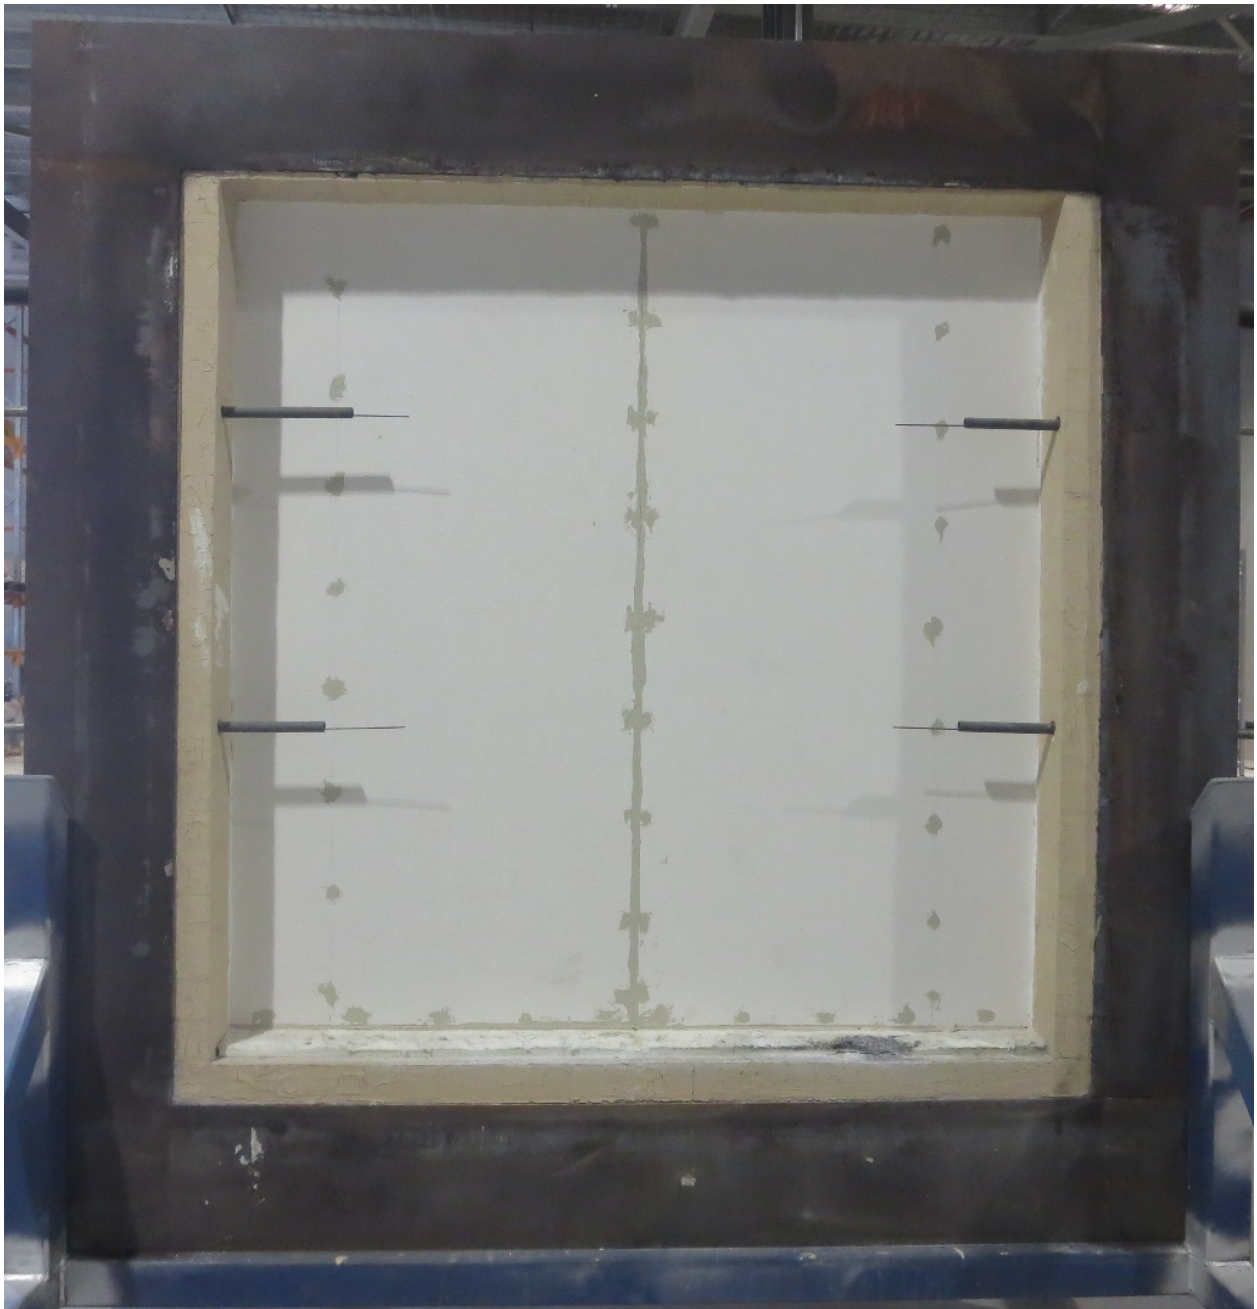
Photo 1 – Exposed side pre-test

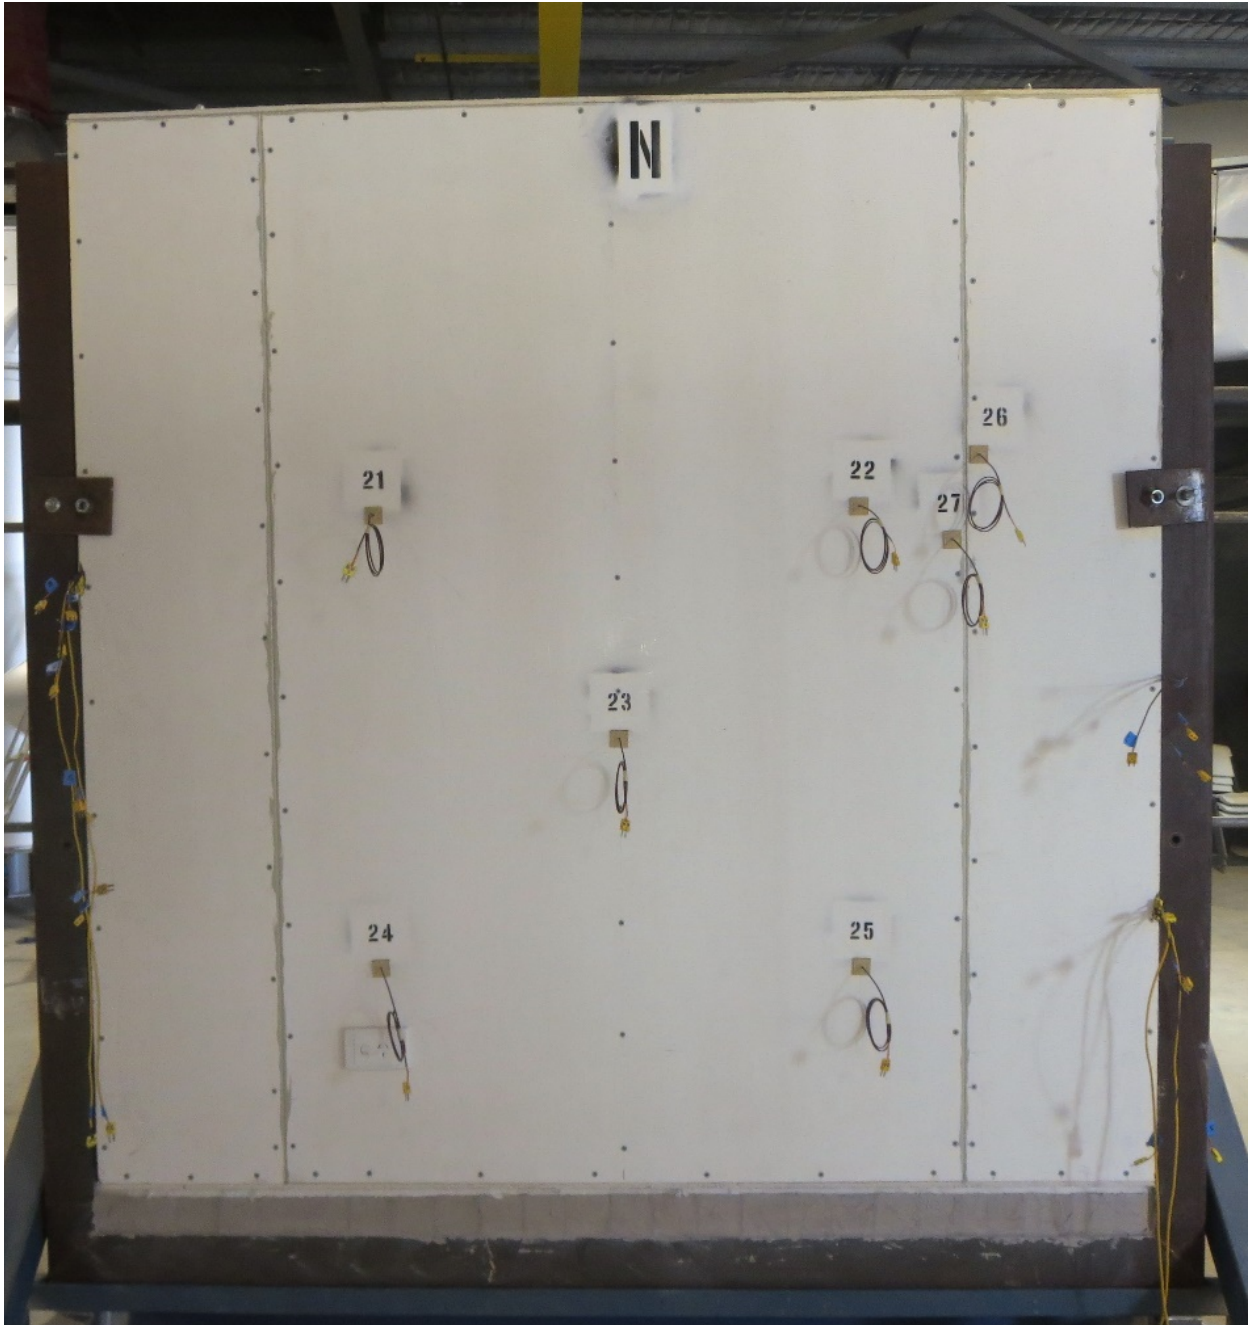
Photo 2 – Unexposed side pre-test

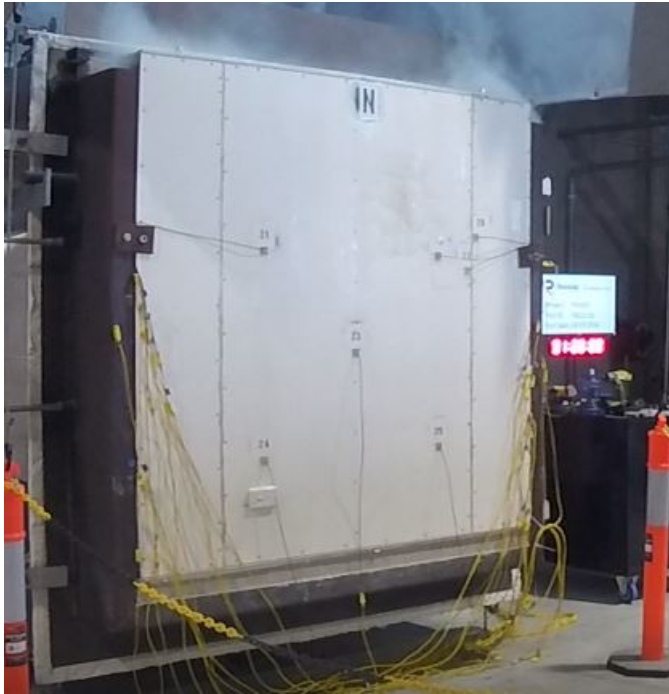
Photo 4 – Cracking at 88 minutes

¹ deterioration of the non-fire side board occurred from 86 minutes onward but a cotton pad was not available to be used in the final minutes of the test. Had one been applied at 88-89 minutes it is not known if it would have passed due to the observed breakdown in the board surface. No flaming or fissures occurred during this period, only surface cracking.

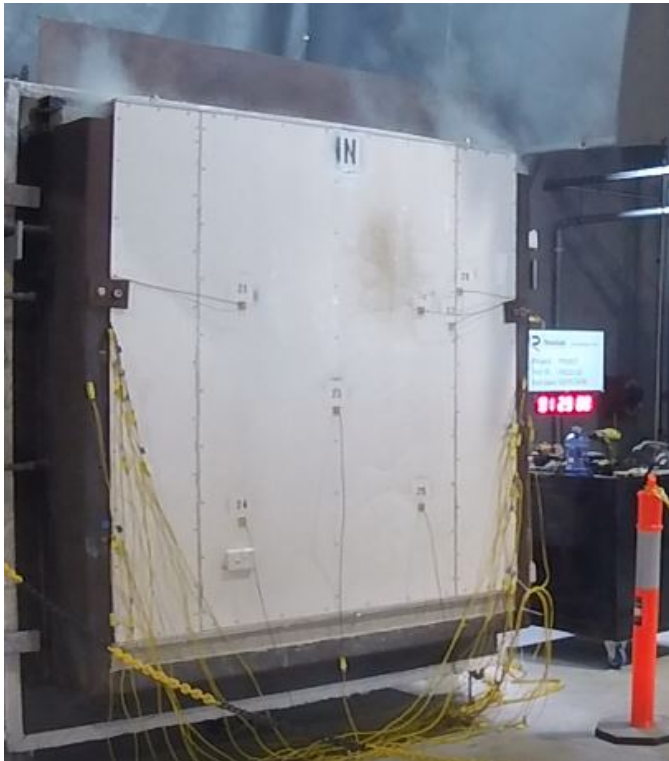
Photo 5 – Cracking & discolouration at 89 minutes

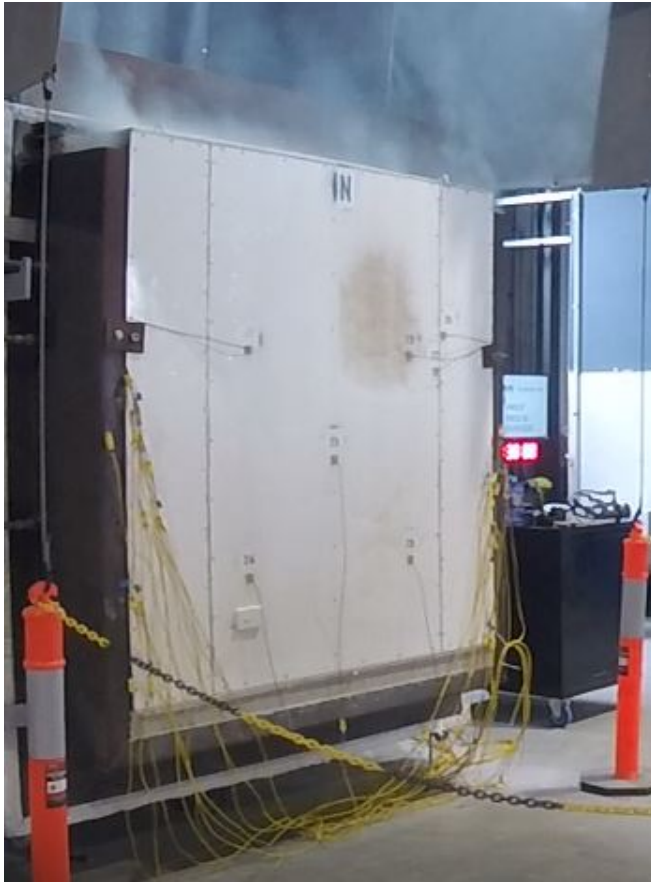
Photo 6 – Cracking and discolouration at 90 minutes

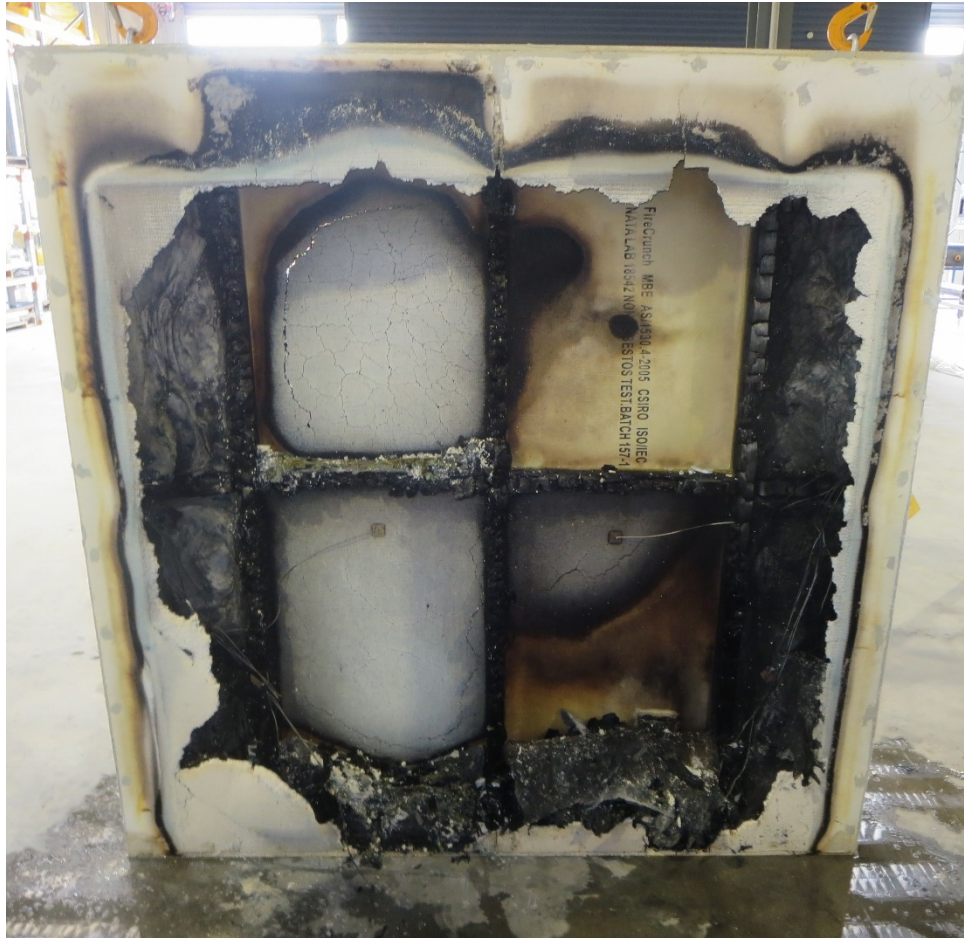
Photo 7 – Exposed side post test (after extinguishment of timbers)

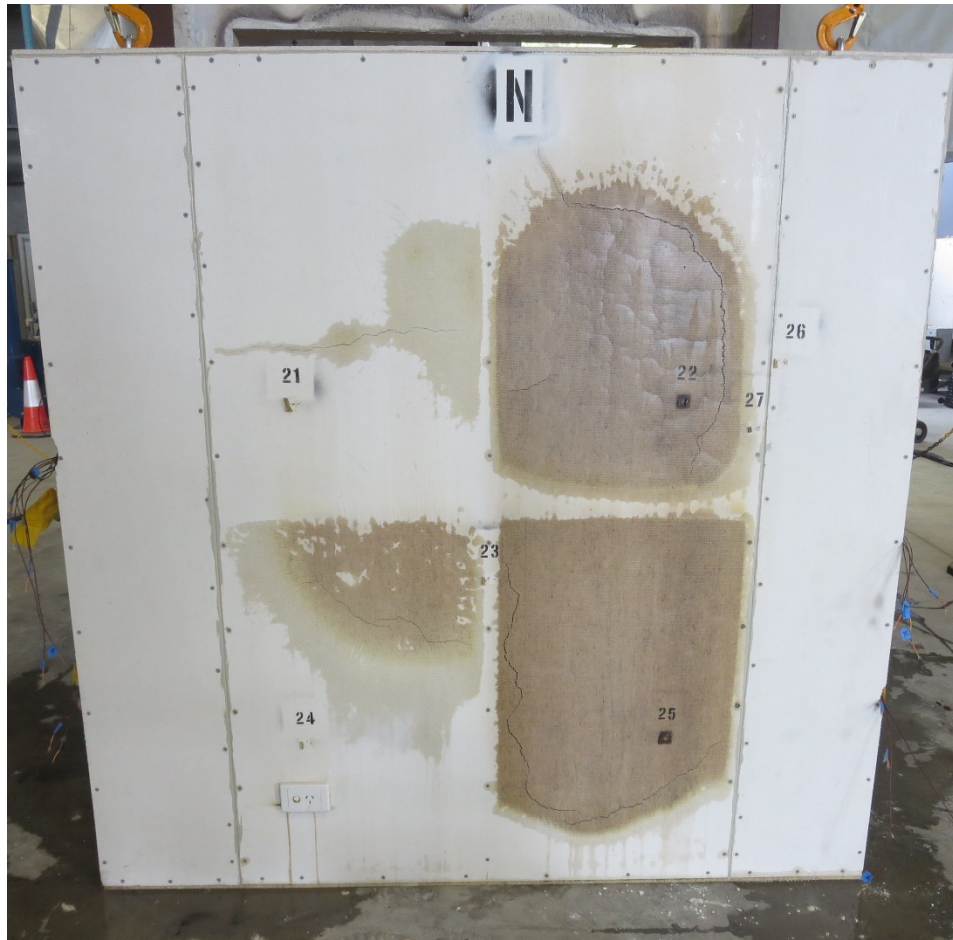
Photo 8 – Unexposed side post test (after extinguishment of timbers)
