Test Report – Fire Resistance:

TESTING PERFORMED ON: A timber framed, stud wall with one layer of R2.5 x 90mm thk earthwool and sheeted with a single layer of 10mm thk SE FireCrunch board each side.

TEST DATE:	04/09/2018
REPORT WRITTEN BY:	M. Lewis
REPORT DATE:	12/09/2018
RTL REPORT NO:	TR-F025.01 (PR0057)
TEST ID:	FR33.S3/2018
SCOPE:	Measurement of fire resistance in general accordance with AS 1530.4-2014 Sections 1, 2 and 3

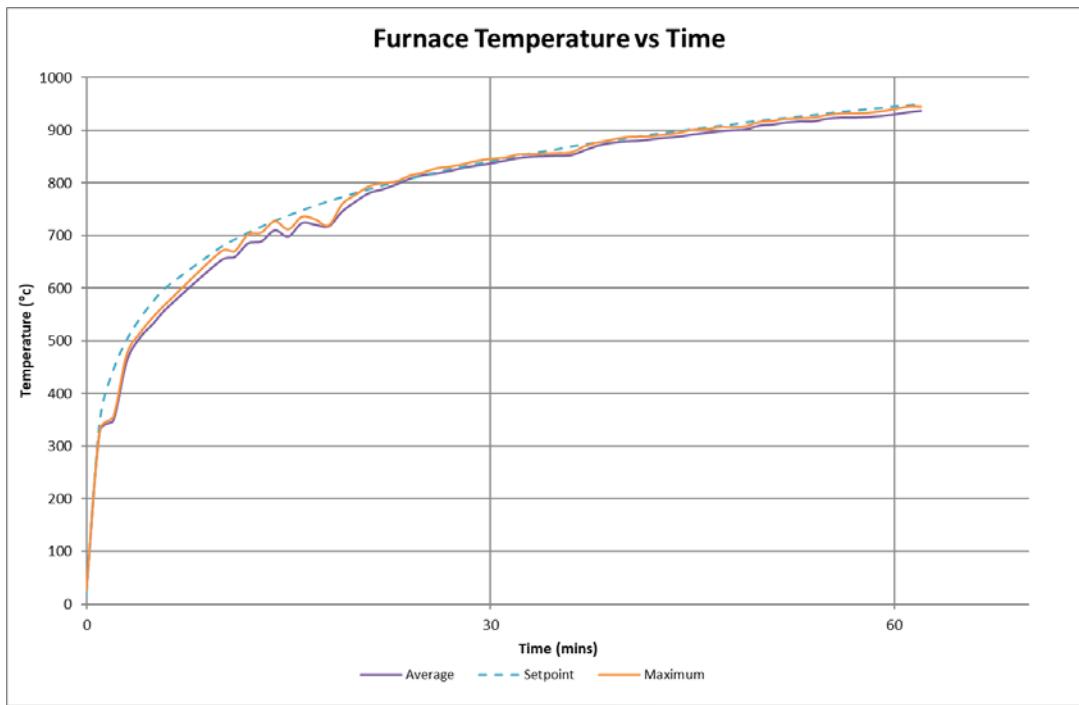
Figure 1 – Furnace Temperature vs Time

Furnace Heating Conditions – Temperature Curve

The temperature of the furnace shall be controlled to vary with time, as close as possible, in accordance with the following relationship:

$$T = 345 \log_{10}(8t + 1) + 20$$

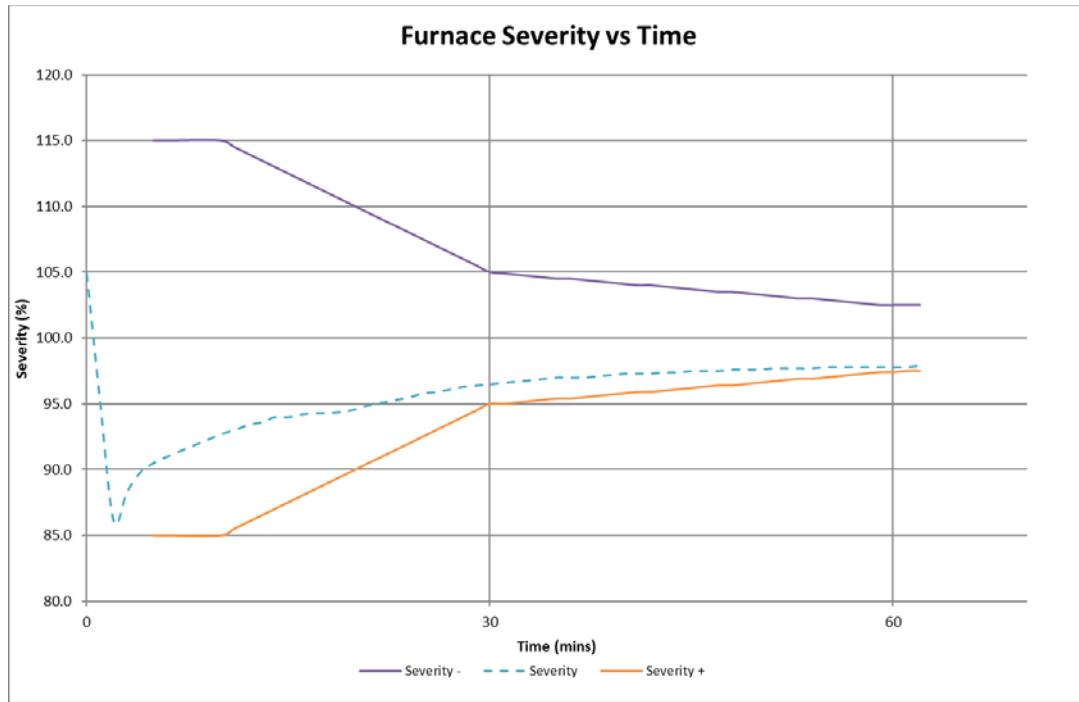
Figure 2 – Furnace Severity vs Time

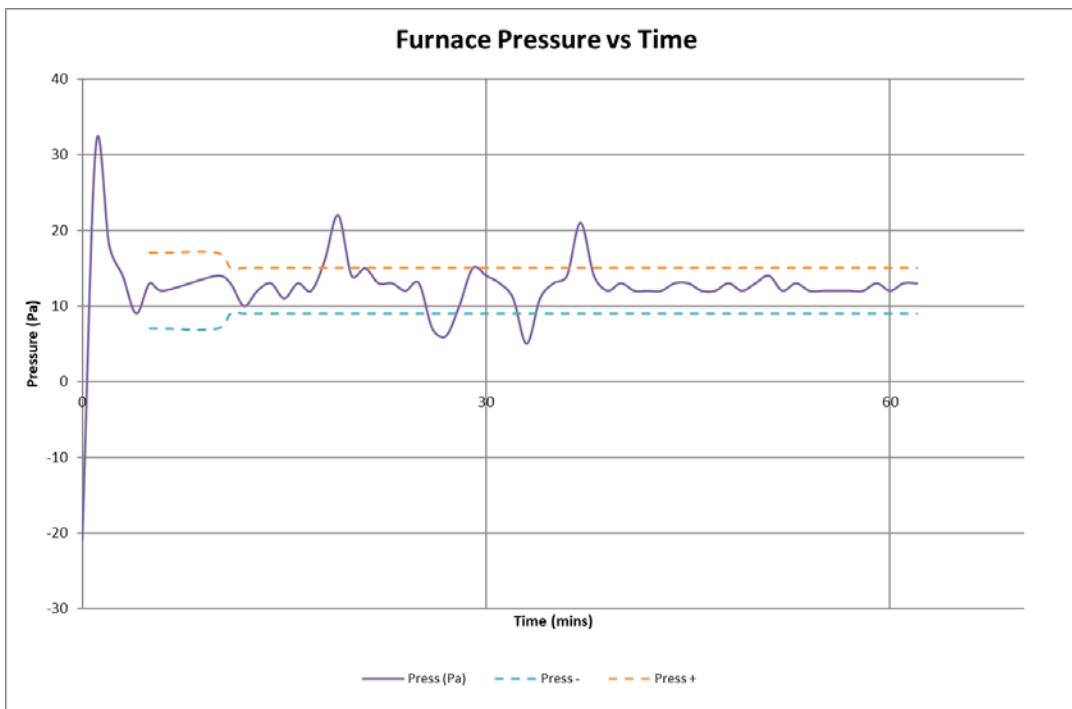
Figure 3 – Furnace Pressure vs Time

During the test the internal furnace pressure fluctuated outside of the control parameters intermittently.

Furnace Pressure Differential

Furnace pressure was measured with a Dwyer Magnehelic pressure transmitter (S:N 71640), with a probe located 100mm from the face of the test specimen.

The pressure variations within the furnace chamber are not expected to have detrimentally affected the performance of the test.

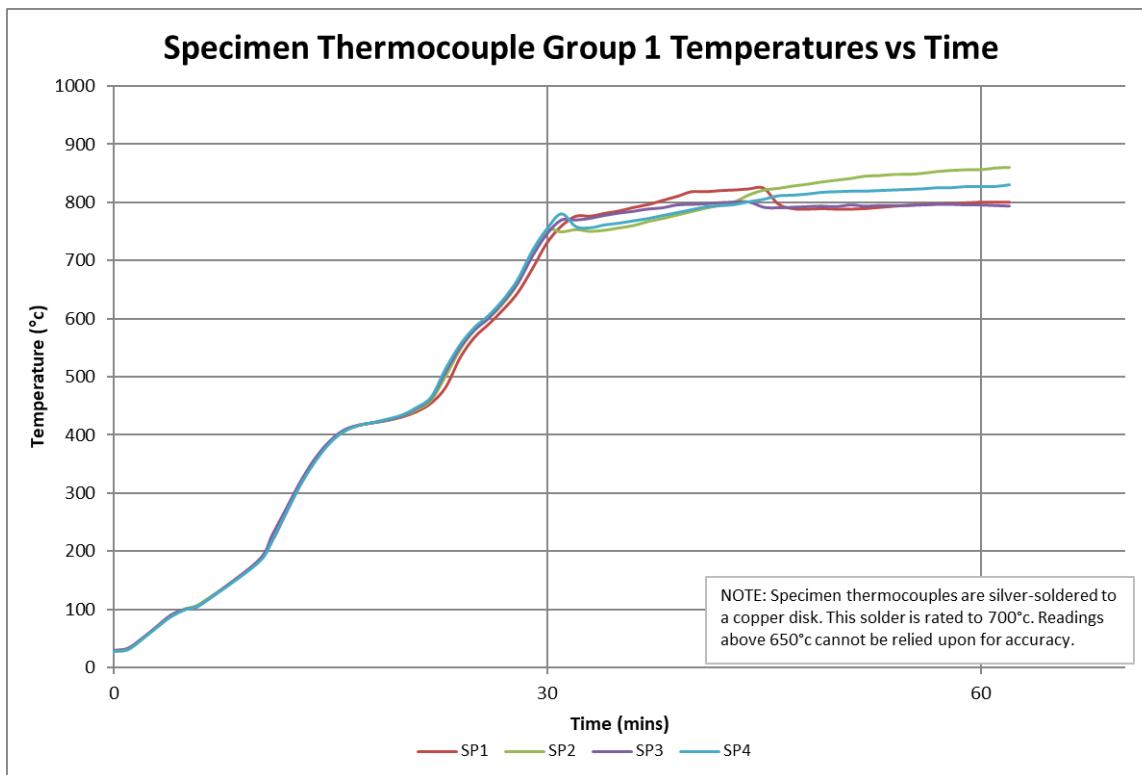
Figure 4 – Specimen Group 1 Temperatures vs Time

**Table 1 – Specimen Thermocouple Locations**

Group Location	T/C Location	T/C Designation
Specimen Group 1	Unexposed face of fire side board – NW	SP1
	Unexposed face of fire side board – SW	SP2
	Unexposed face of fire side board – NE	SP3
	Unexposed face of fire side board – SE	SP4
Specimen Group 2	Non-fire side of insulation - NW	SP7
	Non-fire side of insulation - SW	SP8
	Non-fire side of insulation – NE	SP9
	Non-fire side of insulation - SE	SP10
Specimen Group 3	Non-fire side board - NW	SP11
	Non-fire side board – NE	SP12
	Non-fire side board – Central	SP13
	Non-fire side board – SW	SP14
Specimen Group 4	Non-fire side board - SW	SP15
	RHS of vertical board joint	SP16
	LHS of vertical board joint	SP17

Table 2 – Specimen Group 1 Temperatures

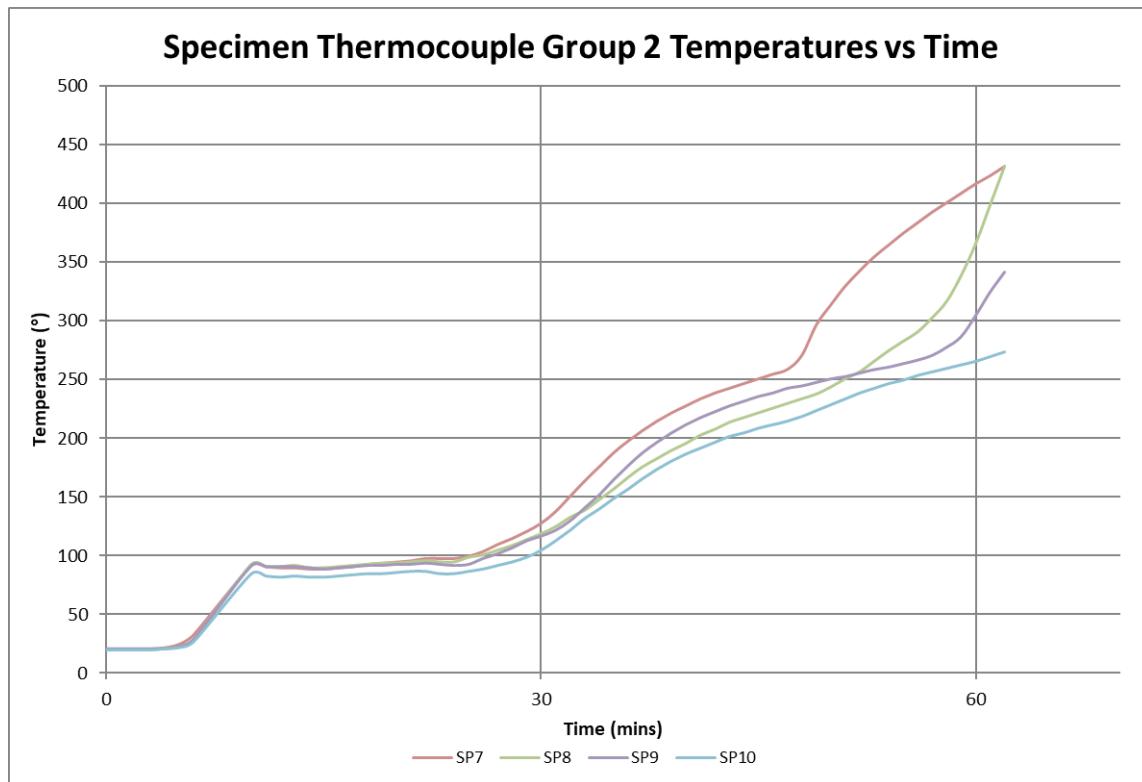
**Figure 5 – Specimen Group 2 Temperatures vs Time**

Table 3 – Specimen Group 2 Temperatures

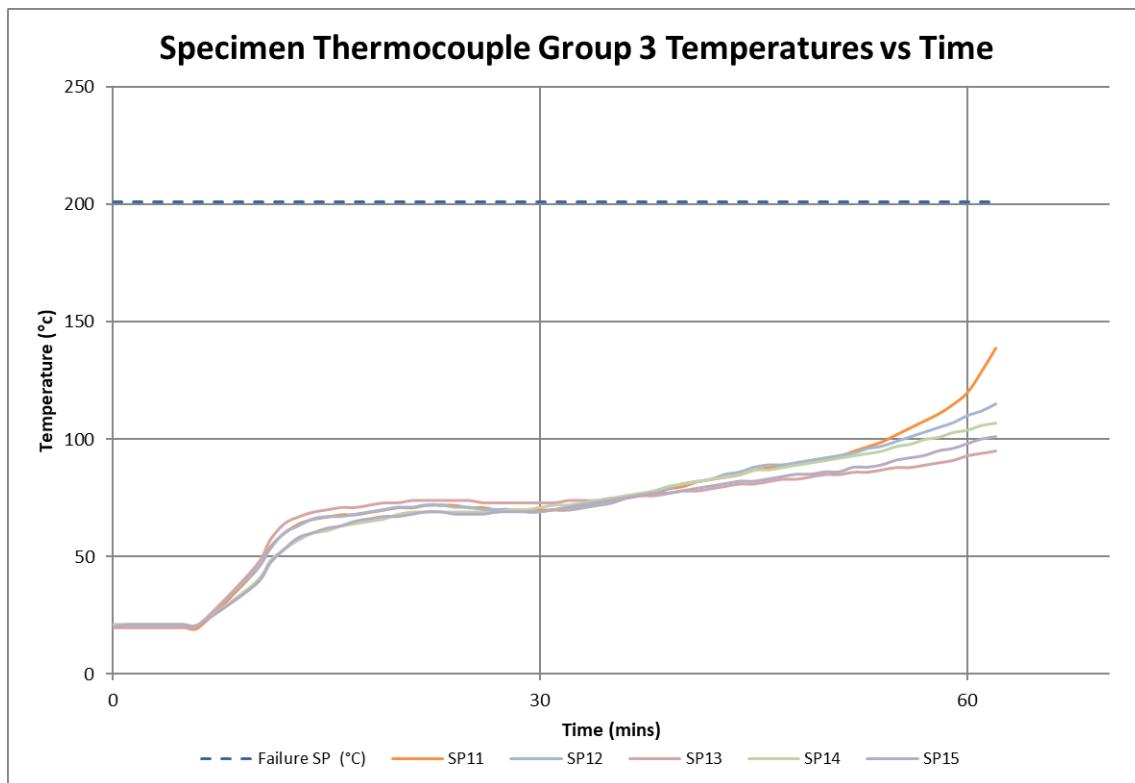
Figure 6 – Specimen Group 3 Temperatures vs Time

Table 4 – Specimen Group 3 Temperatures

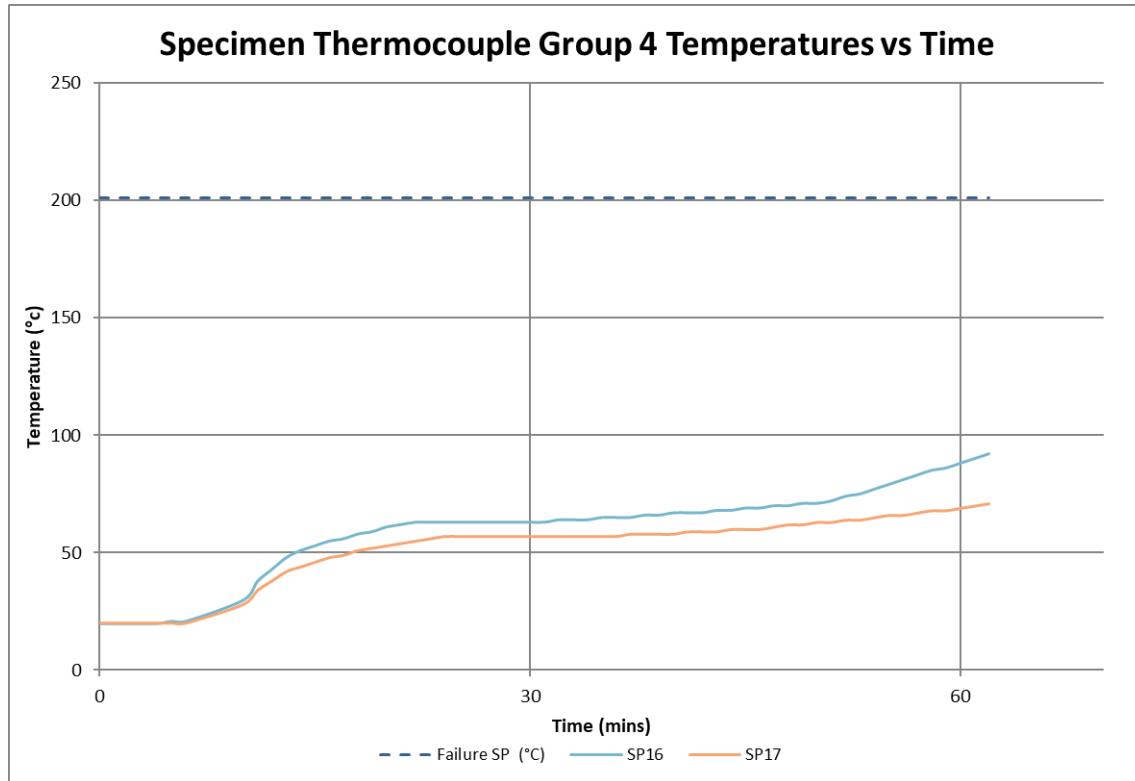
**Figure 7 – Specimen Group 4 Temperatures vs Time**

Table 5 – Specimen Group 4 Temperatures

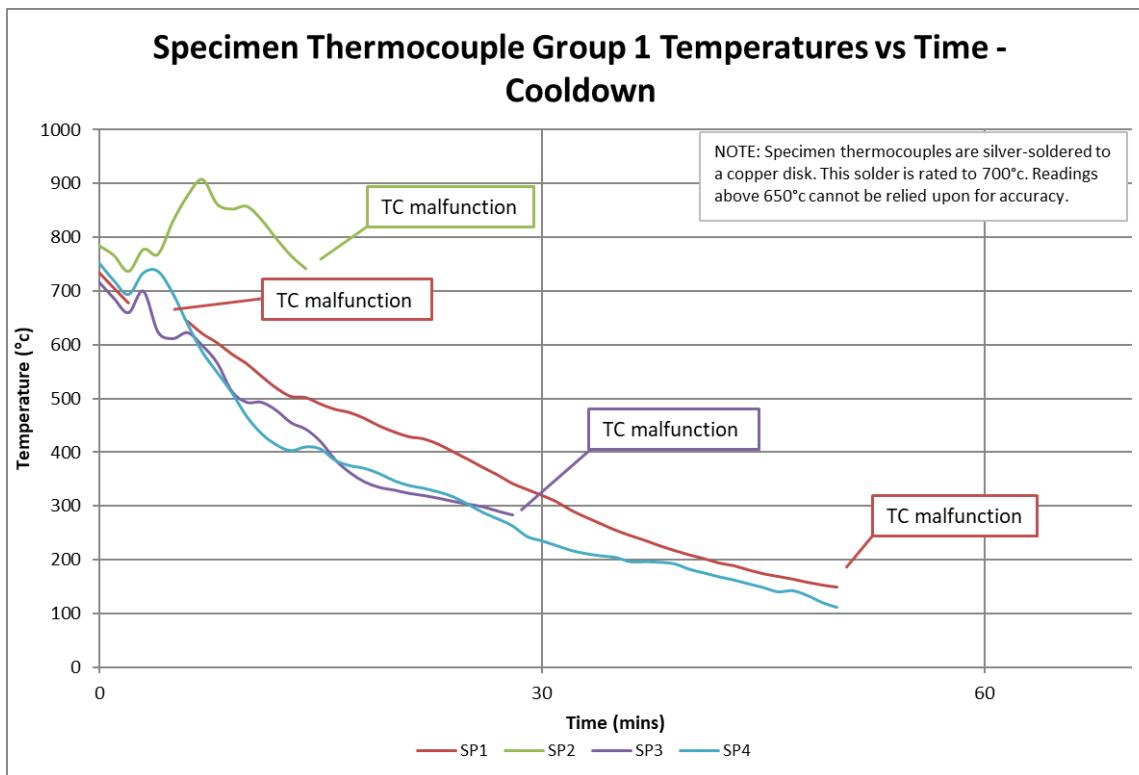
Figure 8 – Specimen Group 1Cooldown Phase vs Time

Table 6 – Specimen Group 1 Temperatures – Cooldown Phase

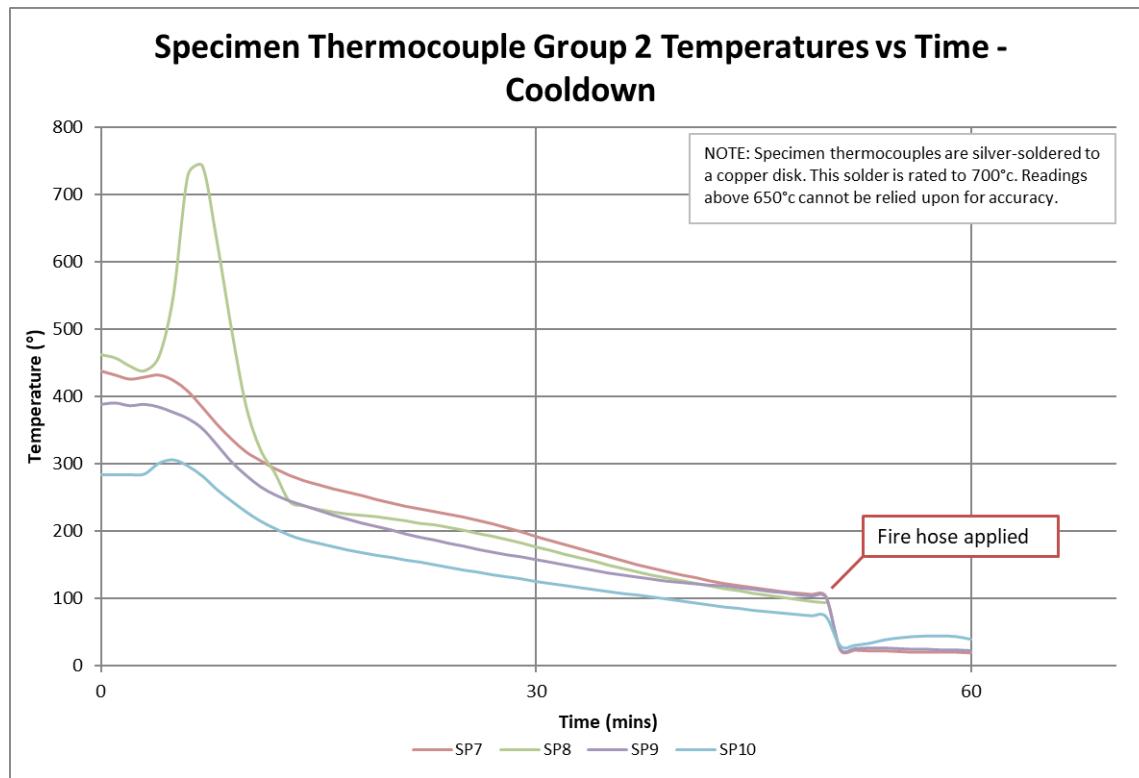
Figure 9 – Specimen Group 2 Cooldown Phase vs Time

Table 7 – Specimen Group 2 Temperatures – Cooldown Phase

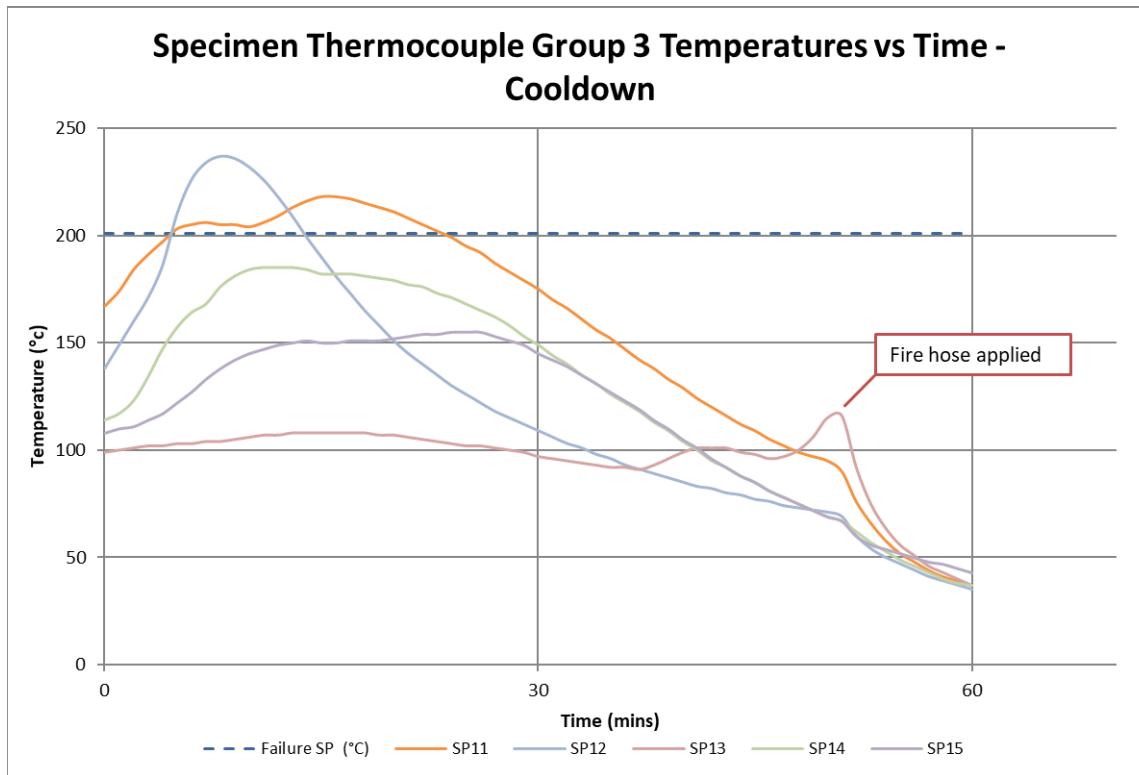
Figure 10 – Specimen Group 3 Cooldown Phase vs Time

AS 1530.8.2 13.8 Performance Criteria (shortened to agreed scope)	Time to failure (min)	Position of failure
Sustained flaming for more than 10 s on the non-fire side for the duration of the 120 min test period	No failure	-
Flaming on the fire-exposed face more than 30 min after completion of heating	109	Centre of wall approx. 150mm down from top.
Mean and maximum temperature rises greater than 140 K and 180 K	67 67 68 112	TC11 exceeded max TC12 exceeded max Group3 exceeded ave TC16 NFS upper joint
Mean and maximum temperature of internal faces exceed 250°C and 300°C respectively more than 30 min after completion of heating phase	92	TC1 max and TC1& TC2 ave

Table 8 – Specimen Group 3 Temperatures – Cooldown Phase

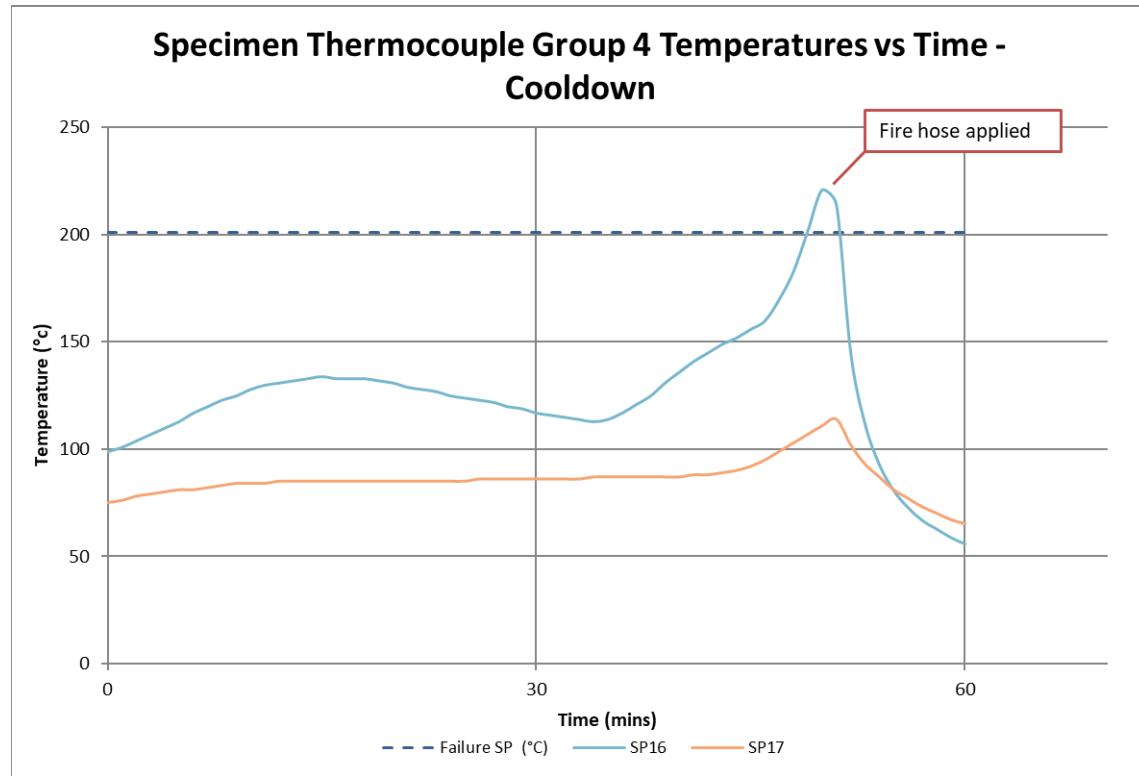
Figure 11 – Specimen Group 4 Cooldown Phase vs Time

Table 9 – Specimen Group 4 Temperatures – Cooldown Phase

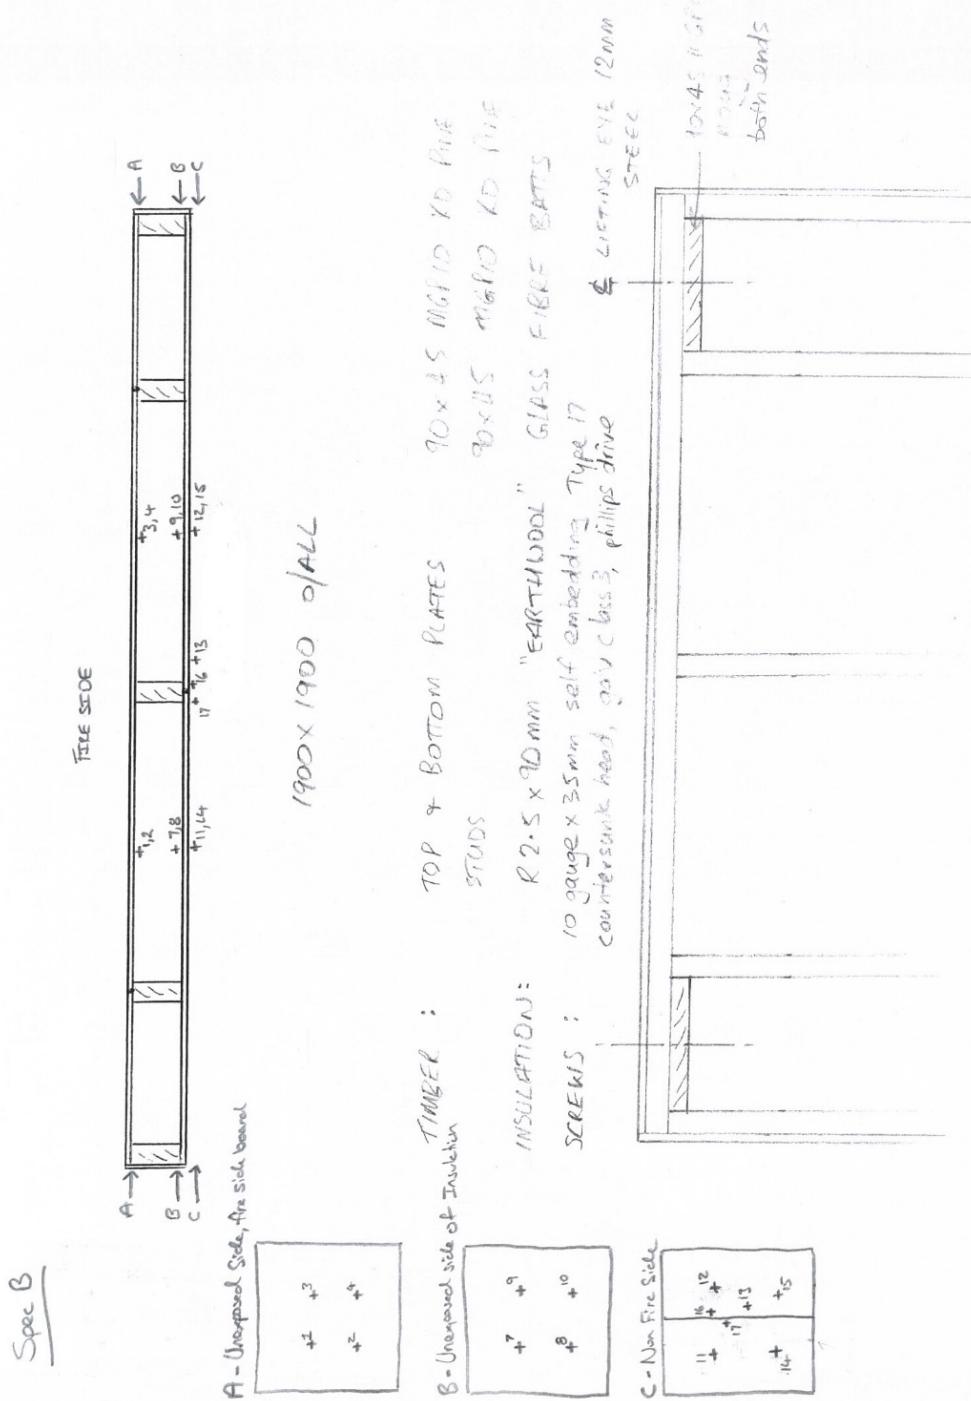
Drawing 1 – Client supplied drawing. Lab added TC locations

1 X 90 X 45MM SINGLE TIMBER MPG10 STUD FRAME

1 X 10MM FCA SHEET EACH SIDE

INSULATION R2.5 "EARTHWOOL" GLASS WOOL BATT 90MM IN FRAME

AS1530.4 FIRE SEALANT BOSTIK FIRE BAN TO JOINTS AND PERIMETERS

SEALANT IN 3 X 3MM BEADS DOWN EACH (VERTICAL) JOINT 45MM STUD FACE

4MM FIRE GAP BETWEEN VERTICALLY SET BOARDS FILLED WITH SAME FIRE SEALANT

FIXED WITH NEEDLE POINT STAINLESS STEEL SCREWS AT MIN 200 CENTRES. 10 GAUGE x 35mm SELF

EMBEDDING TYPE 17, COUNTERSUNK HEAD, GALV CLASS 3, PHILLIPS DRIVE

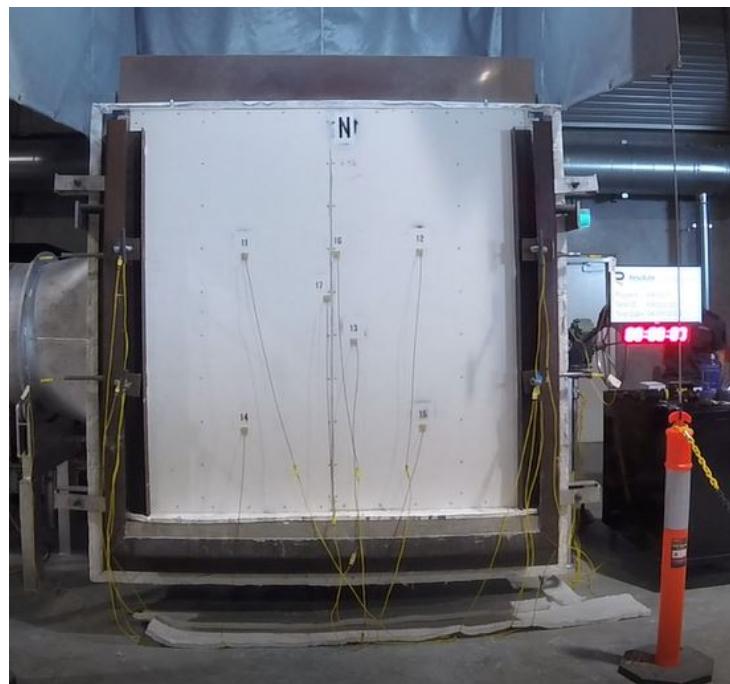
Photo 1 – Specimen at start of test

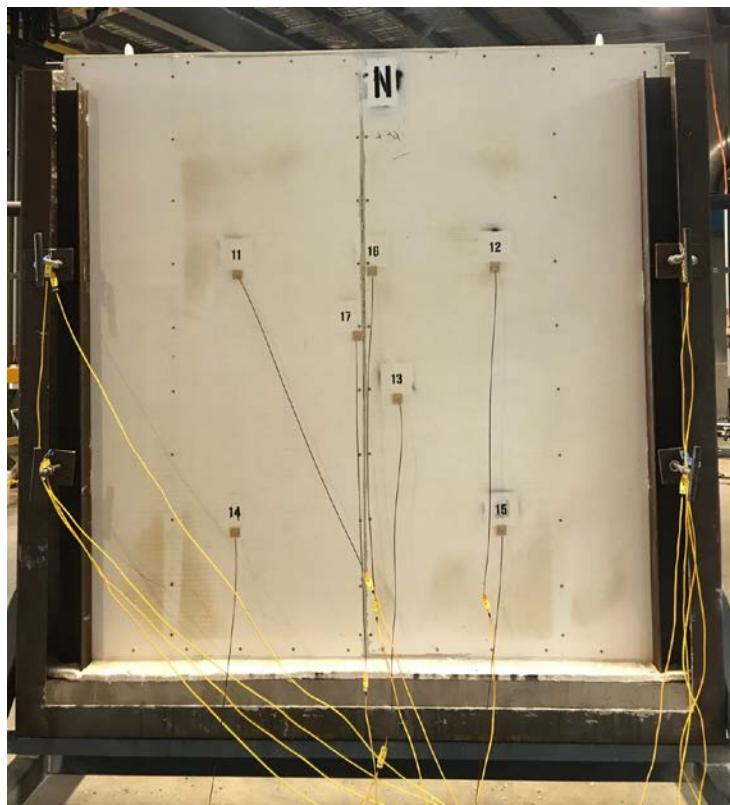
Photo 2 – Specimen at end of 60-minute fire test

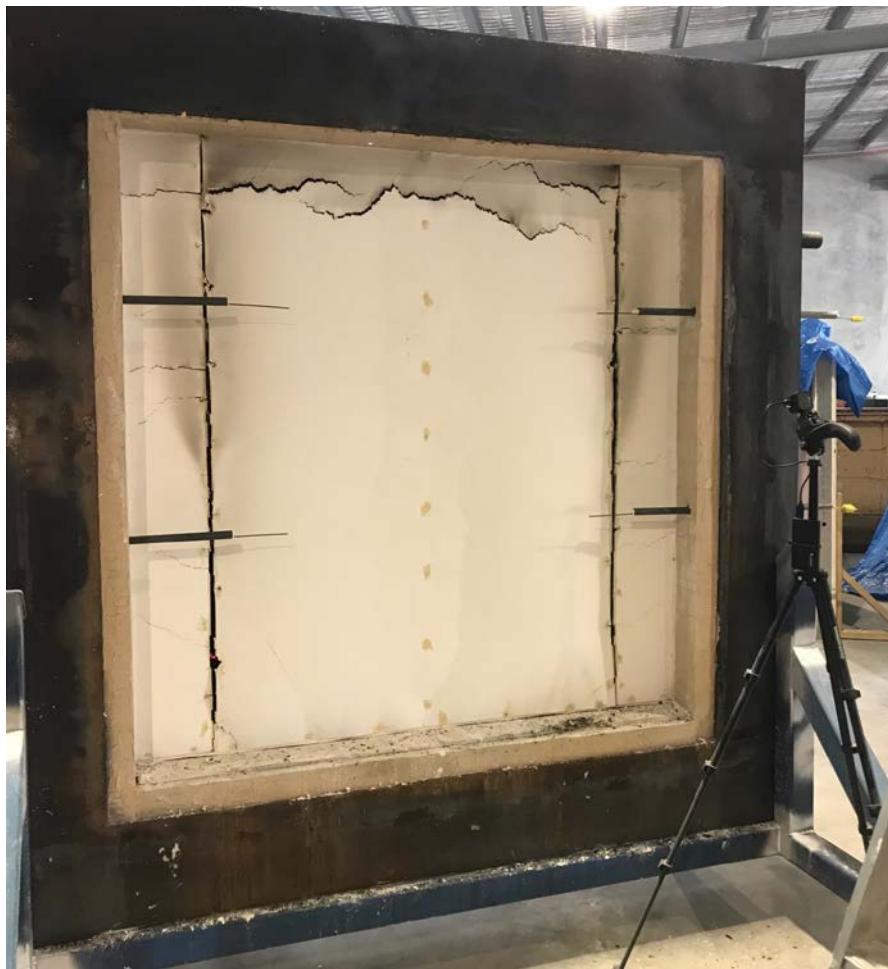
Photo 3 – Specimen at end of 60-minute fire test

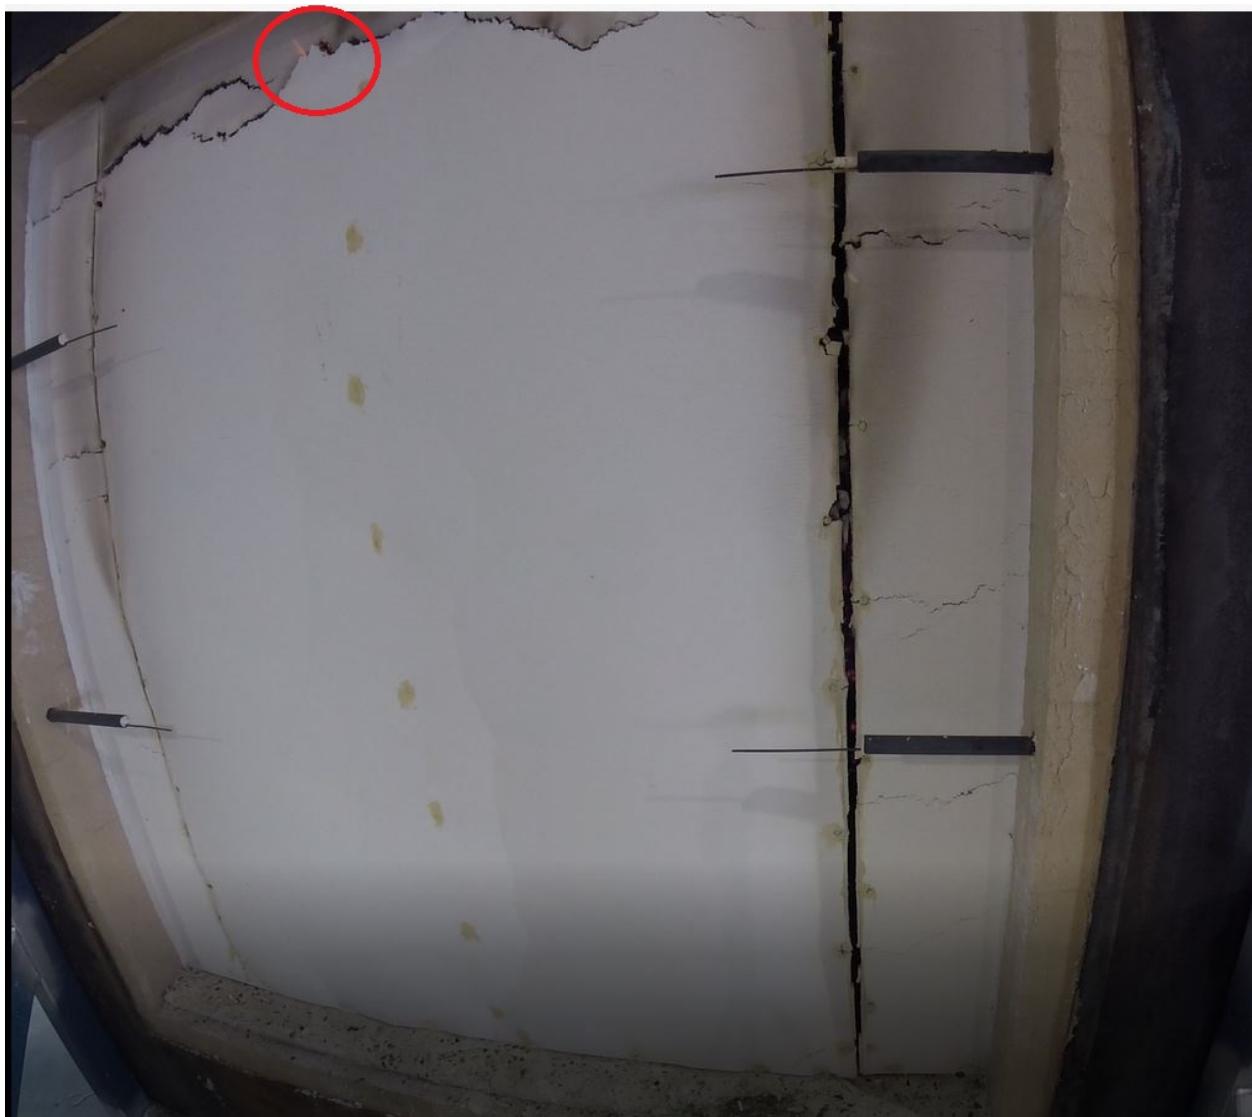
Photo 4 – Very start of visible flaming from top gap

TIME		Observations
Min	Sec	
10	0	Slight smoke from edge
15	0	NFS no change
17	0	Cracking heard from sample
20	0	NFS no change
30	0	NFS no change
33	0	No major deflection noticed. Cracking sound continuing intermittently
45	0	NFS no change
50	0	Cracking sounds. NFS no change
55	0	Cracking sounds. NFS no change
60	0	NFS no change
62	0	Furnace burners off. Specimen removed
		Following specimen removal, the specimen was monitored for a further 60 minutes. Observations against failure criteria noted in Section 15 – Post Test Observations.

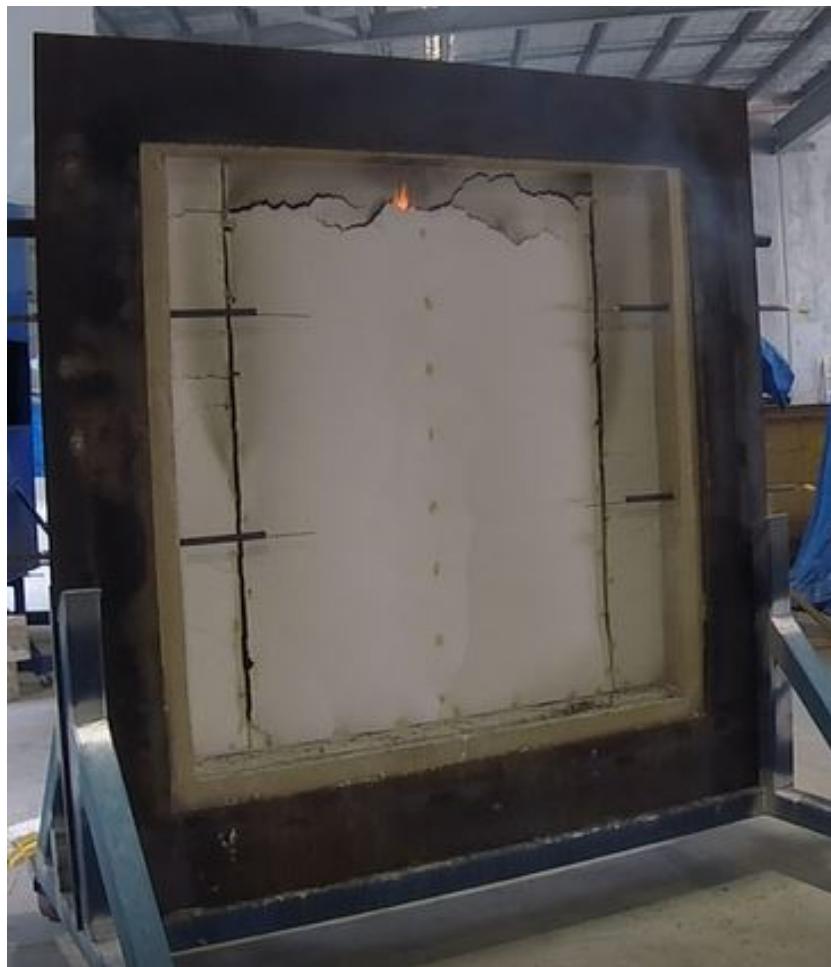
Photo 5 – Flaming prior to extinguishment

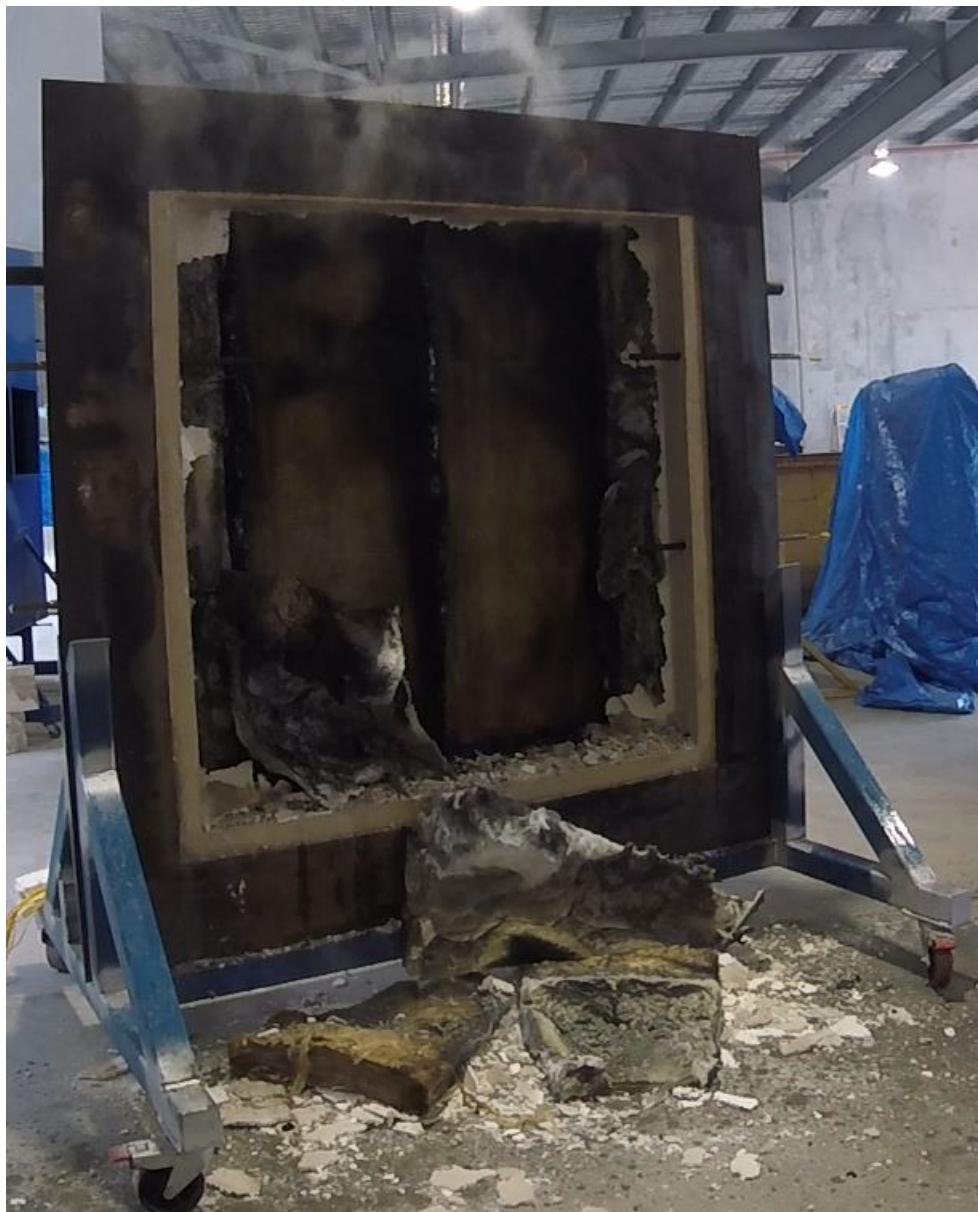
Photo 6 – Specimen at end of test
