TEST REPORT NO.: 23 – 0237

Client Reference: FIRECRUNCH K TYPE (MgSO4) magnesium oxide sulphate

composite fire resistant cladding

Analysis / Project: Asbestos and Chloride Analysis

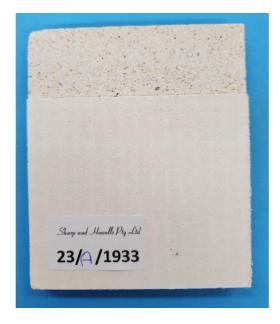
(23/A/1933)

Sample Images (As Received):

Lab Number:	23/A/1933		
Sample Marked:	FIRECRUNCH K TYPE (MgSO4) magnesium oxide sulphate composite fire resistant cladding		
Sample Description:	White compacted board		
Asbestos Result:	Not Detected		
Chloride Content, % w/w:	0.045
