Aerotek Australia Pty Ltd - Treadrite Clear #57727 - 4L 57729-4L 57790-1L 57820-10L 11-02-2025 - Wet Sliptest MO140225-12 14 Feb 2025

Slip Resistance Classification of New Pedestrian Surfaces - AS4586:2013

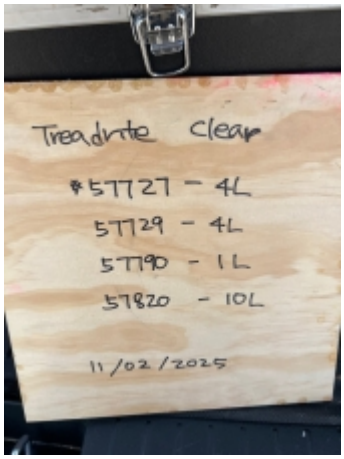
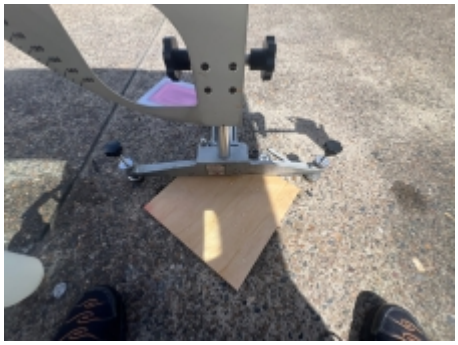
Sample No.	Swing 1	Swing 2	Swing 3	Swing 4	Swing 5	Mean BPN	SCV :	Surface Picture
Area 5	73	73	72	72	71	72	N/A

Reported SRV For Test Area :	70
Variation to Standard Mean BPN Slip Resistance Value (SRV)	70
Corrected Mean BPN (SRV) Slider 55 ONLY	71
CLASSIFICATION using Slider 55 (TRL Slider)	P5 = >44
