Fire resistance of FIRECRUNCH FCA-10 wall system when tested in accordance with AS 1530.4-2014

Assessment Report

Author: Keith Nicholls
Report number: FCO-3550
Version: Initial issue
Date: 5/06/2024
Client: FireCrunch Australasia Pty Ltd

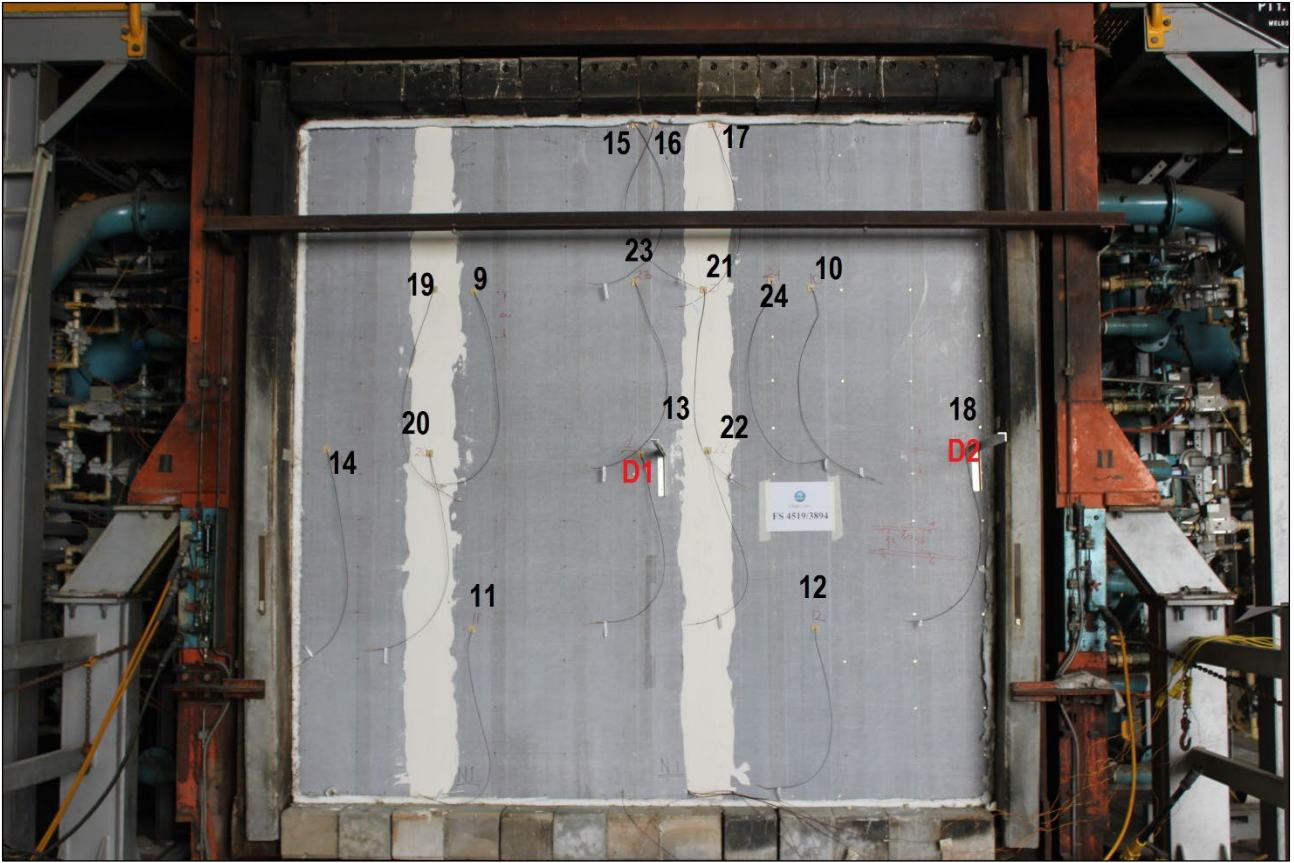
Figure A1: Unexposed face of test specimen detailing external face thermocouple locations

The insulation failure at this time was isolated to a single thermocouple (T/C 24 – Appendix A Figure A1) positioned on the unexposed face of the wall lining over a wall stud which exceeded 203°C at 89 minutes. The ambient temperature on the day of the test was 21°C. After 95 minutes of testing a maximum temperature of 202°C was recorded adjacent to a board joint on the unexposed face of the wall system (T/C 21 - Figure A1), 6 minutes after the first recorded failure.
